**PROJECT FOR RESEARCH AND DEVELOPMENT OF DEMINING
RELATED EQUIPMENT IN CAMBODIA**

**REPAIR &
MAINTENANCE**

PUSH TYPE MACHINE

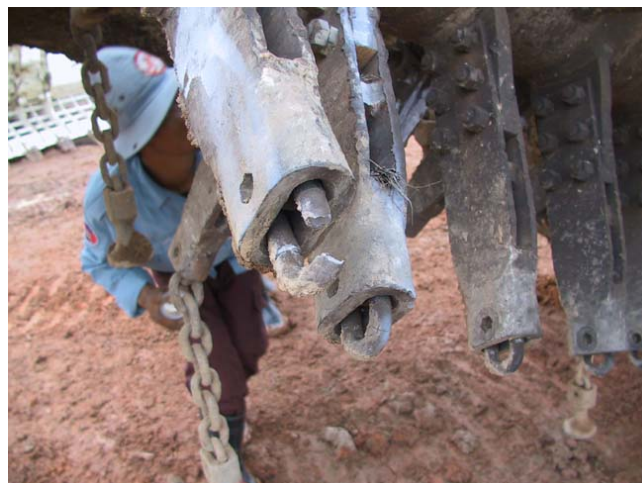
Figure 107: Chains are broken by Anti-tank blast

Time/1pc	Quantity	Total Time	Labor
a) Chain / Replacement	2minutes	1	2minutes	1
b) Bolt / Replacement	5minutes	1	5minutes	1
c) Holder / Repair	15minutes	9	2h 15m	2
d) Anti-blast upper plate / Repair	1hour	1	1hour	2

a) Chain / Replacement	Hexagon wrench
b) Bolt / Replacement	Hexagon wrench, small hammer, punch
c) Holder / Repair	Steel cable, Lever chain block, Burner
d) Anti-blast upper plate / Repair	Welding machine, Big hammer

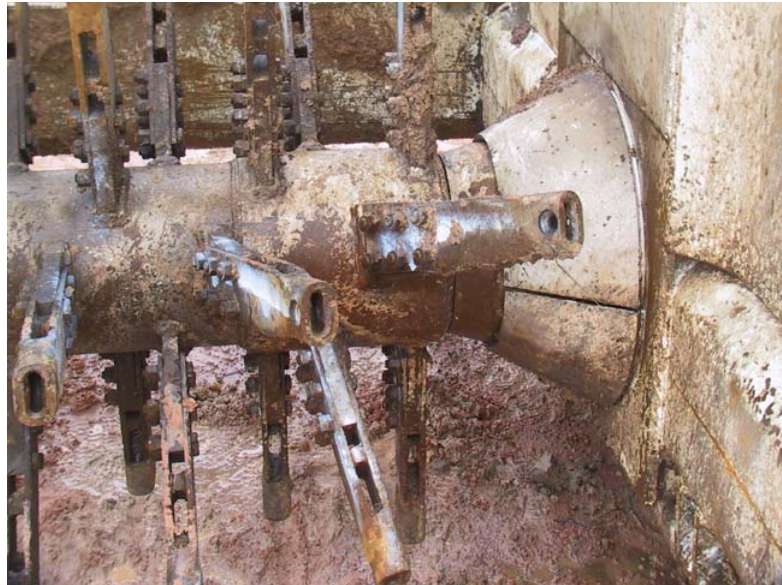
b) Holder

Figure 108: Holder are bending by Anti-tank blast

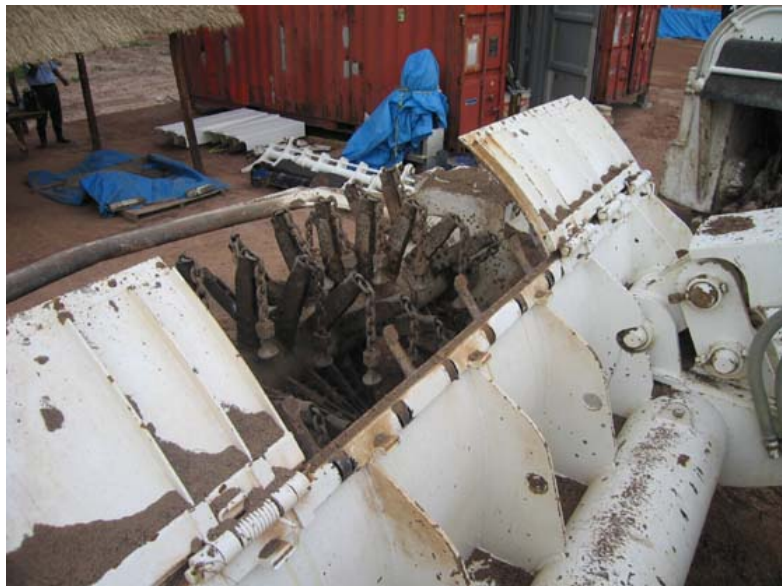
c) Anti-blast upper plate

Figure 109: Anti-blast upper plate are blown away by Anti-tank blast
