PROJECT FOR RESEARCH AND DEVELOPMENT OF DEMINING RELATED EQUIPMENT IN CAMBODIA

No. 3

SURVIVABILITY TEST

PUSH TYPE MACHINE

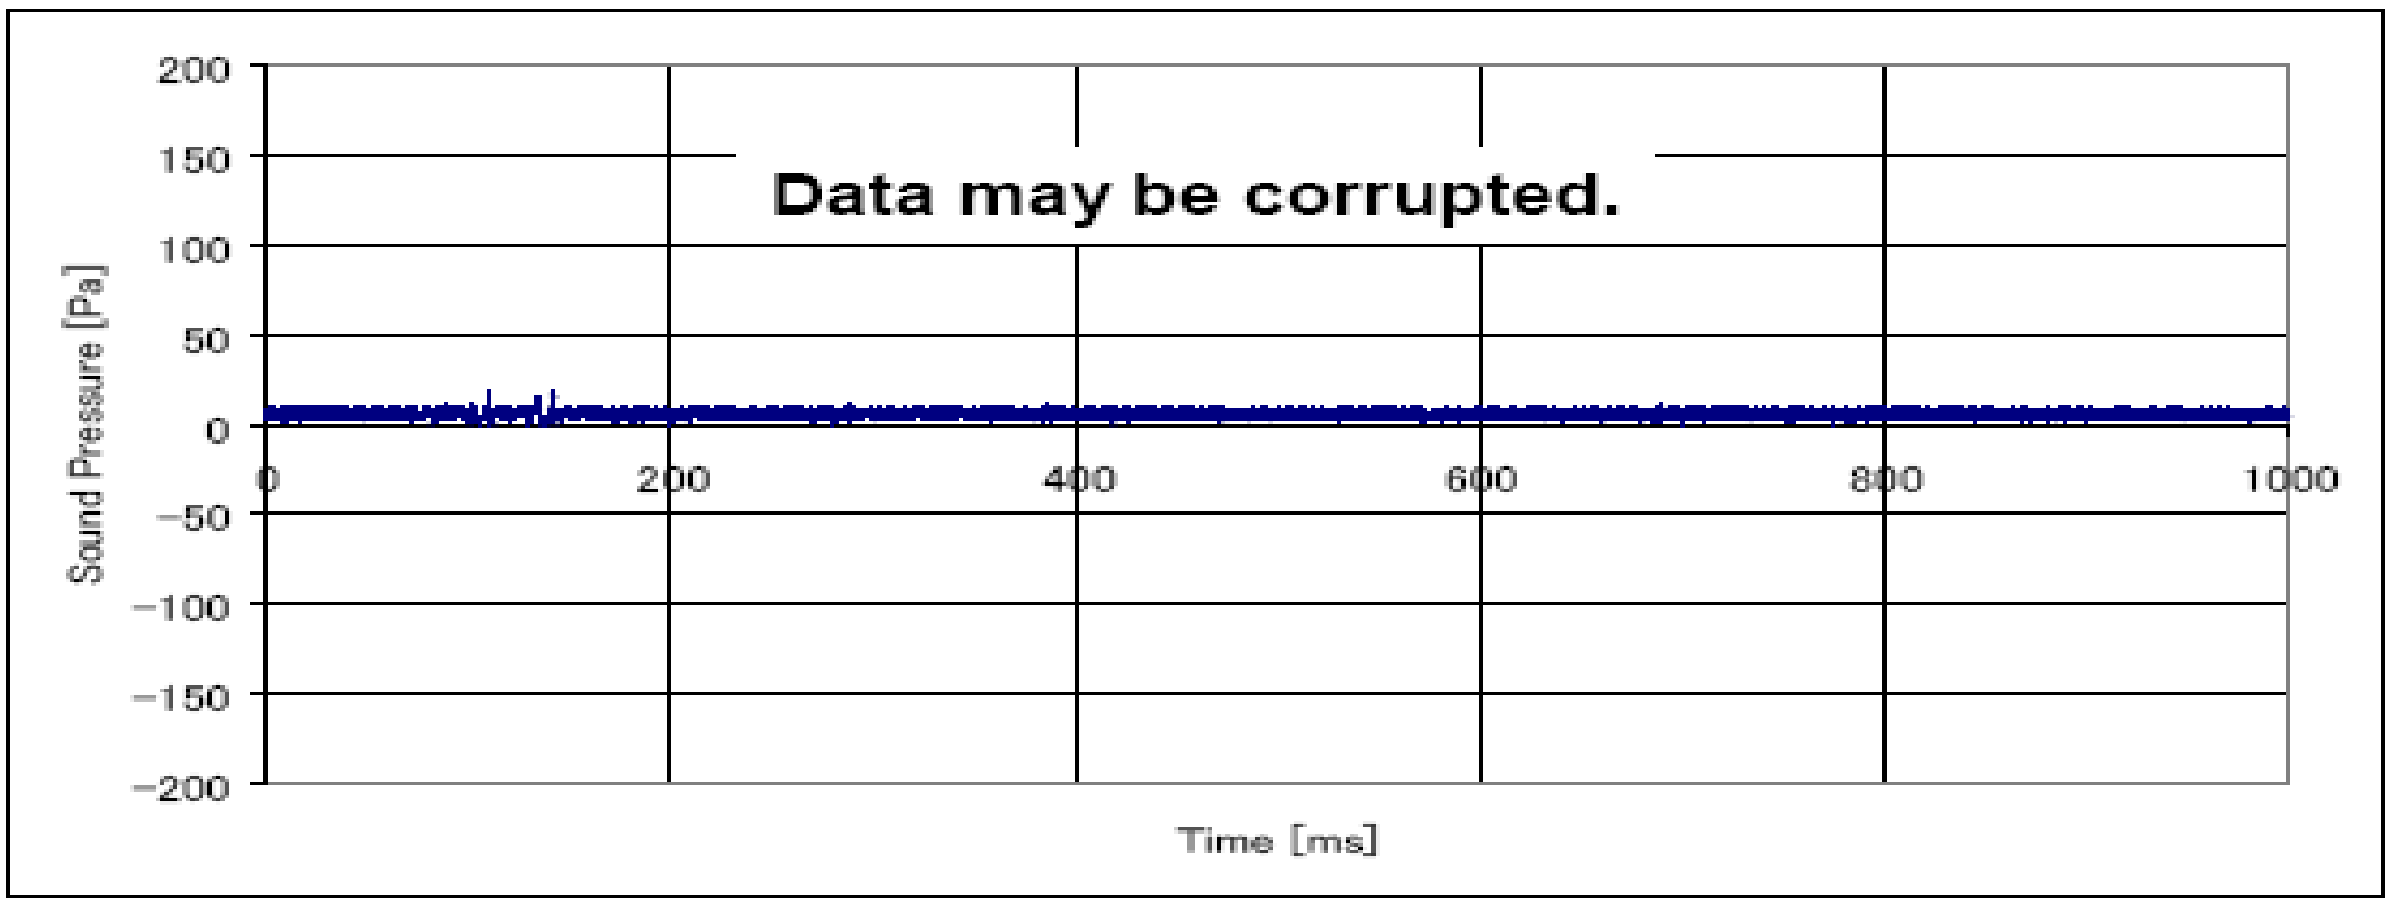
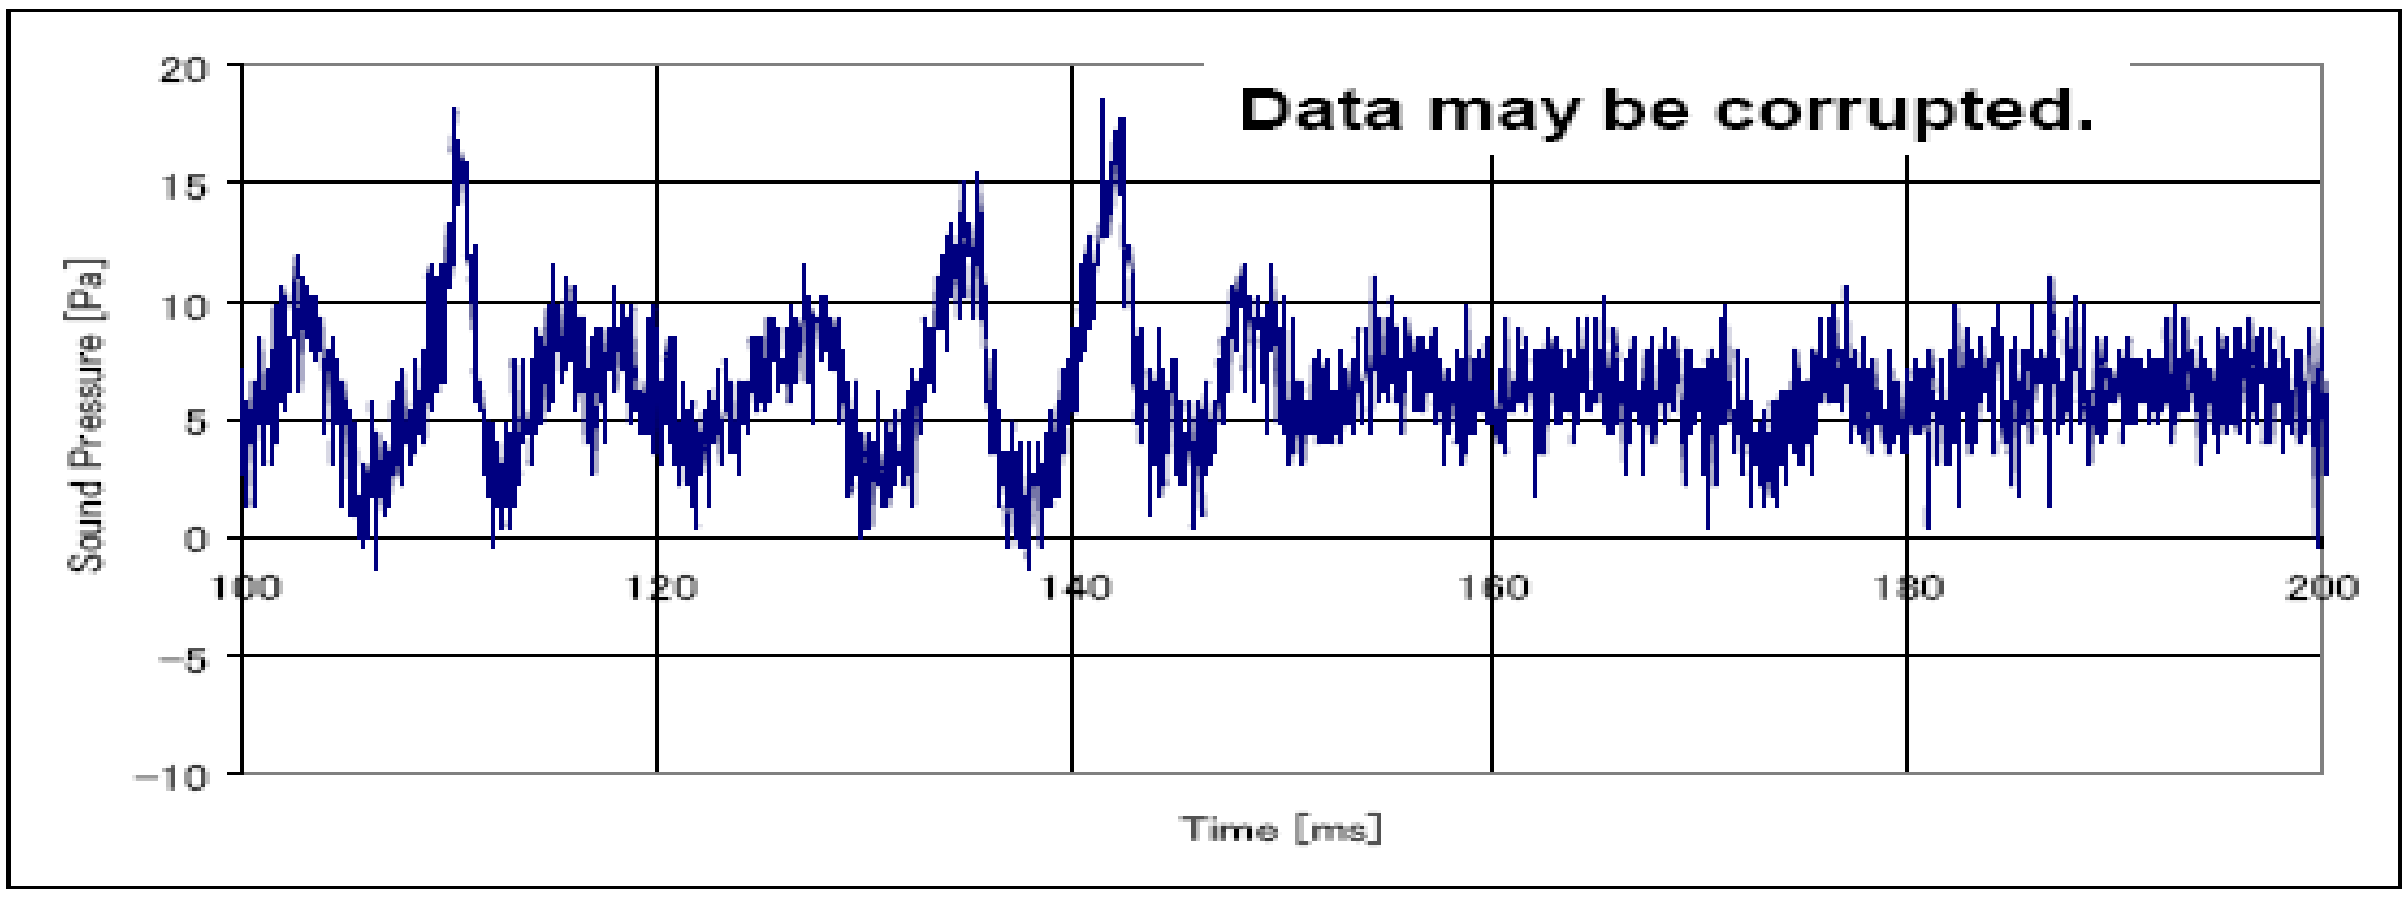
Figure 89: Sound Pressure in Machine #2 (Yamanashi P) - Anti-personnel Mine [1/2]

Figure 90: Sound Pressure in Machine #2 (Yamanashi P) - Anti-personnel Mine [2/2]

Machine #2 (Yamanashi P) has a similar cabin structure to Machine #1 (YAMANASHI S). However, the sound pressure data with Machine #2 differ significantly from the ones with Machine #1 (section 11.2.1). On the other hand, the sound pressure data for anti-tank mines look consistent. Thus, we conclude the sound pressure data are not very reliable.

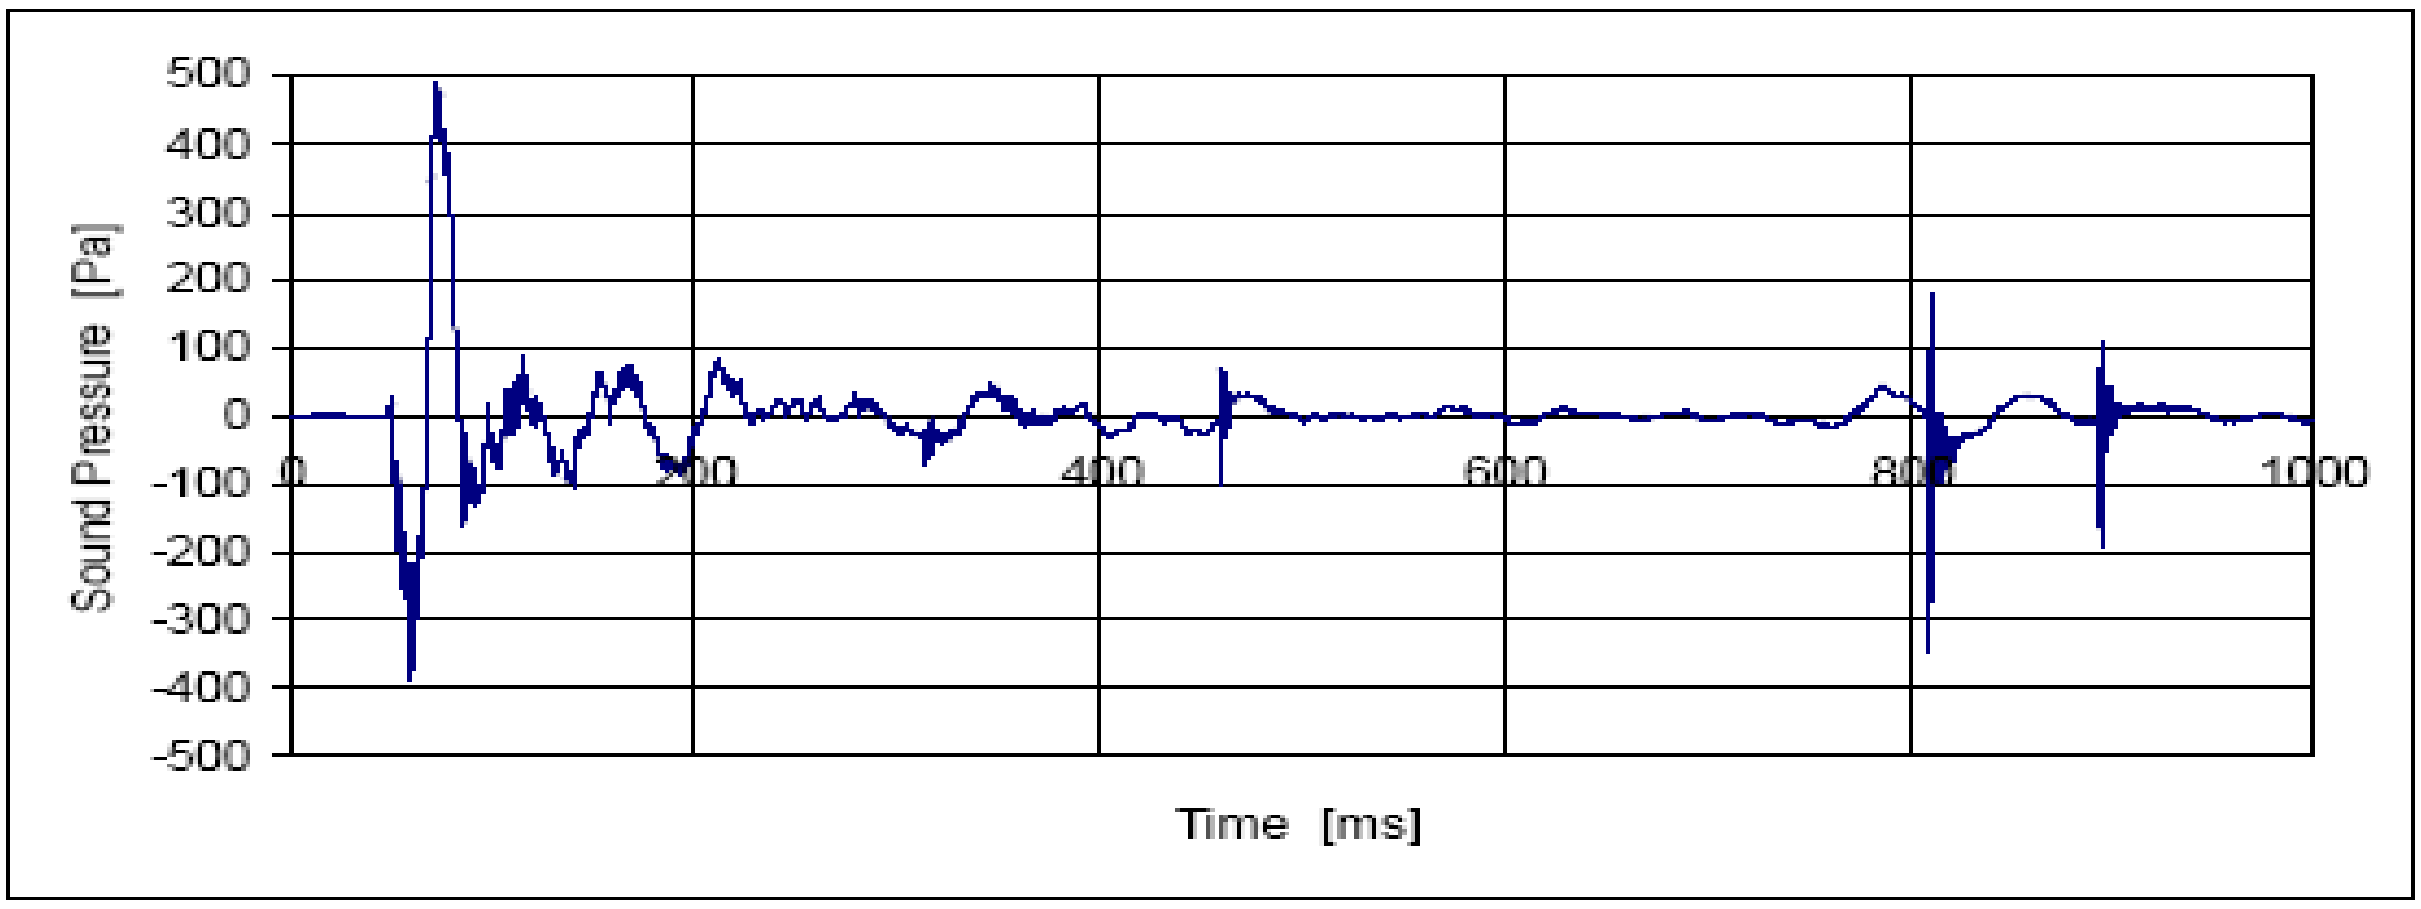
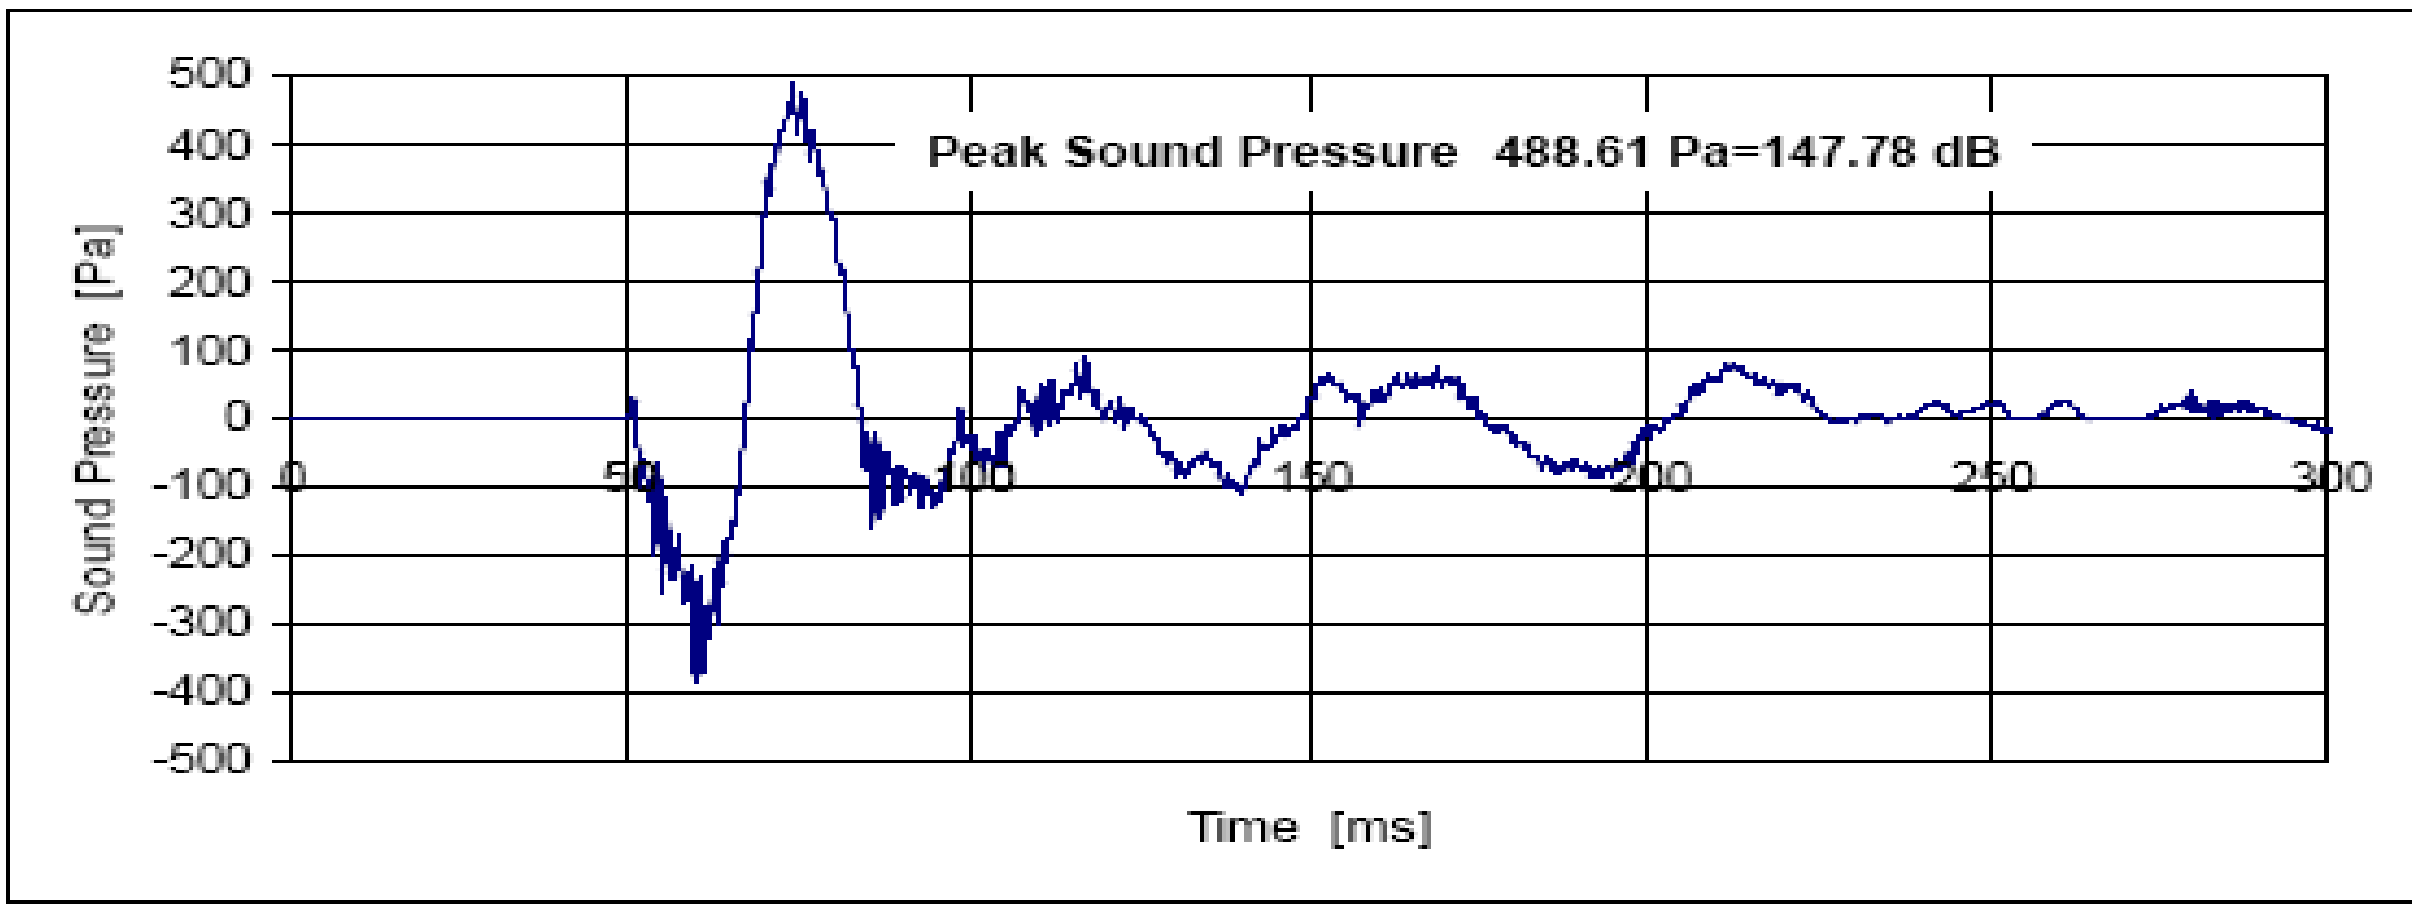
Figure 91: Sound Pressure in Machine #2 (Yamanashi P) - Anti-tank Mine [1/2]

Figure 92: Sound Pressure in Machine #2 (Yamanashi P) - Anti-tank Mine [2/2]

The peak sound pressure for Anti in section 11.2.1 exceeded 200 Pa. The B-duration of this pressure-time history is shown below:

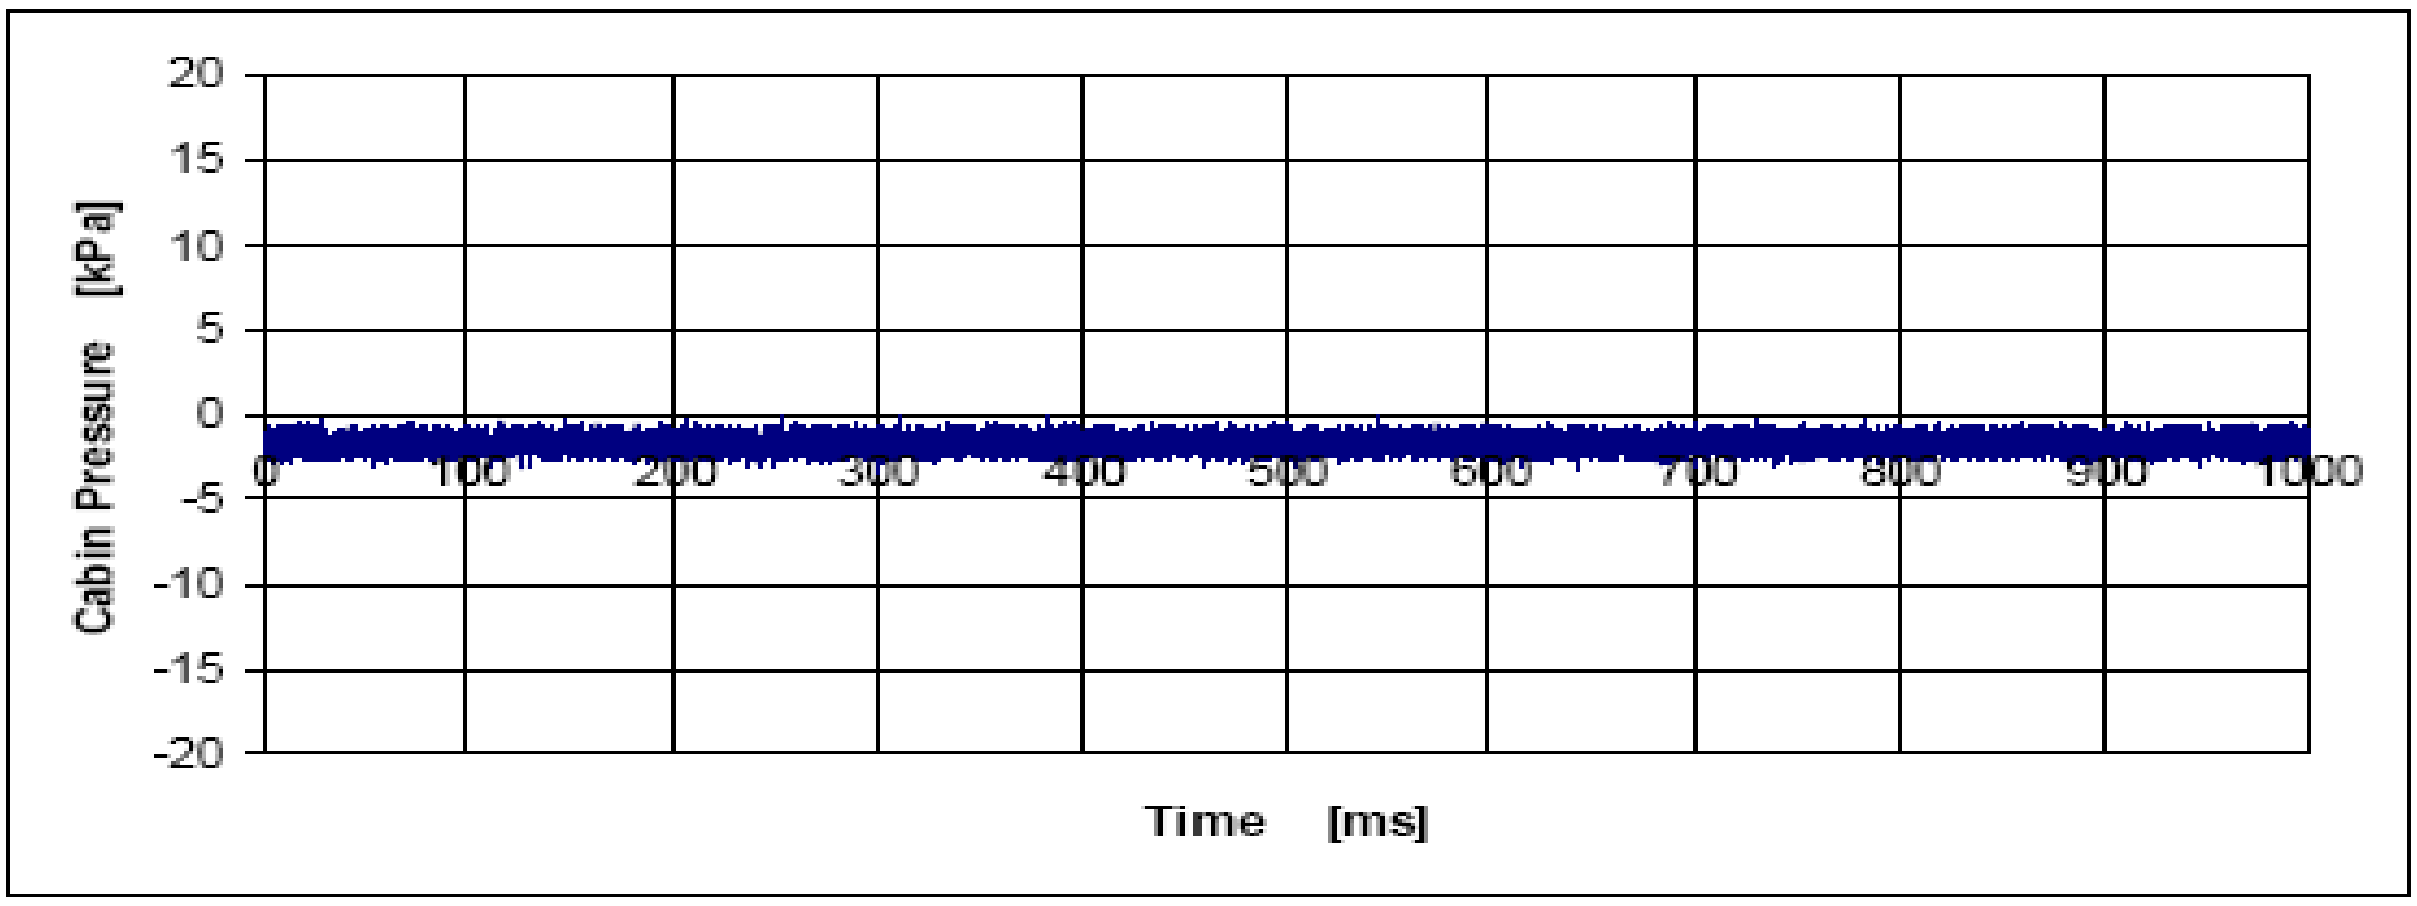
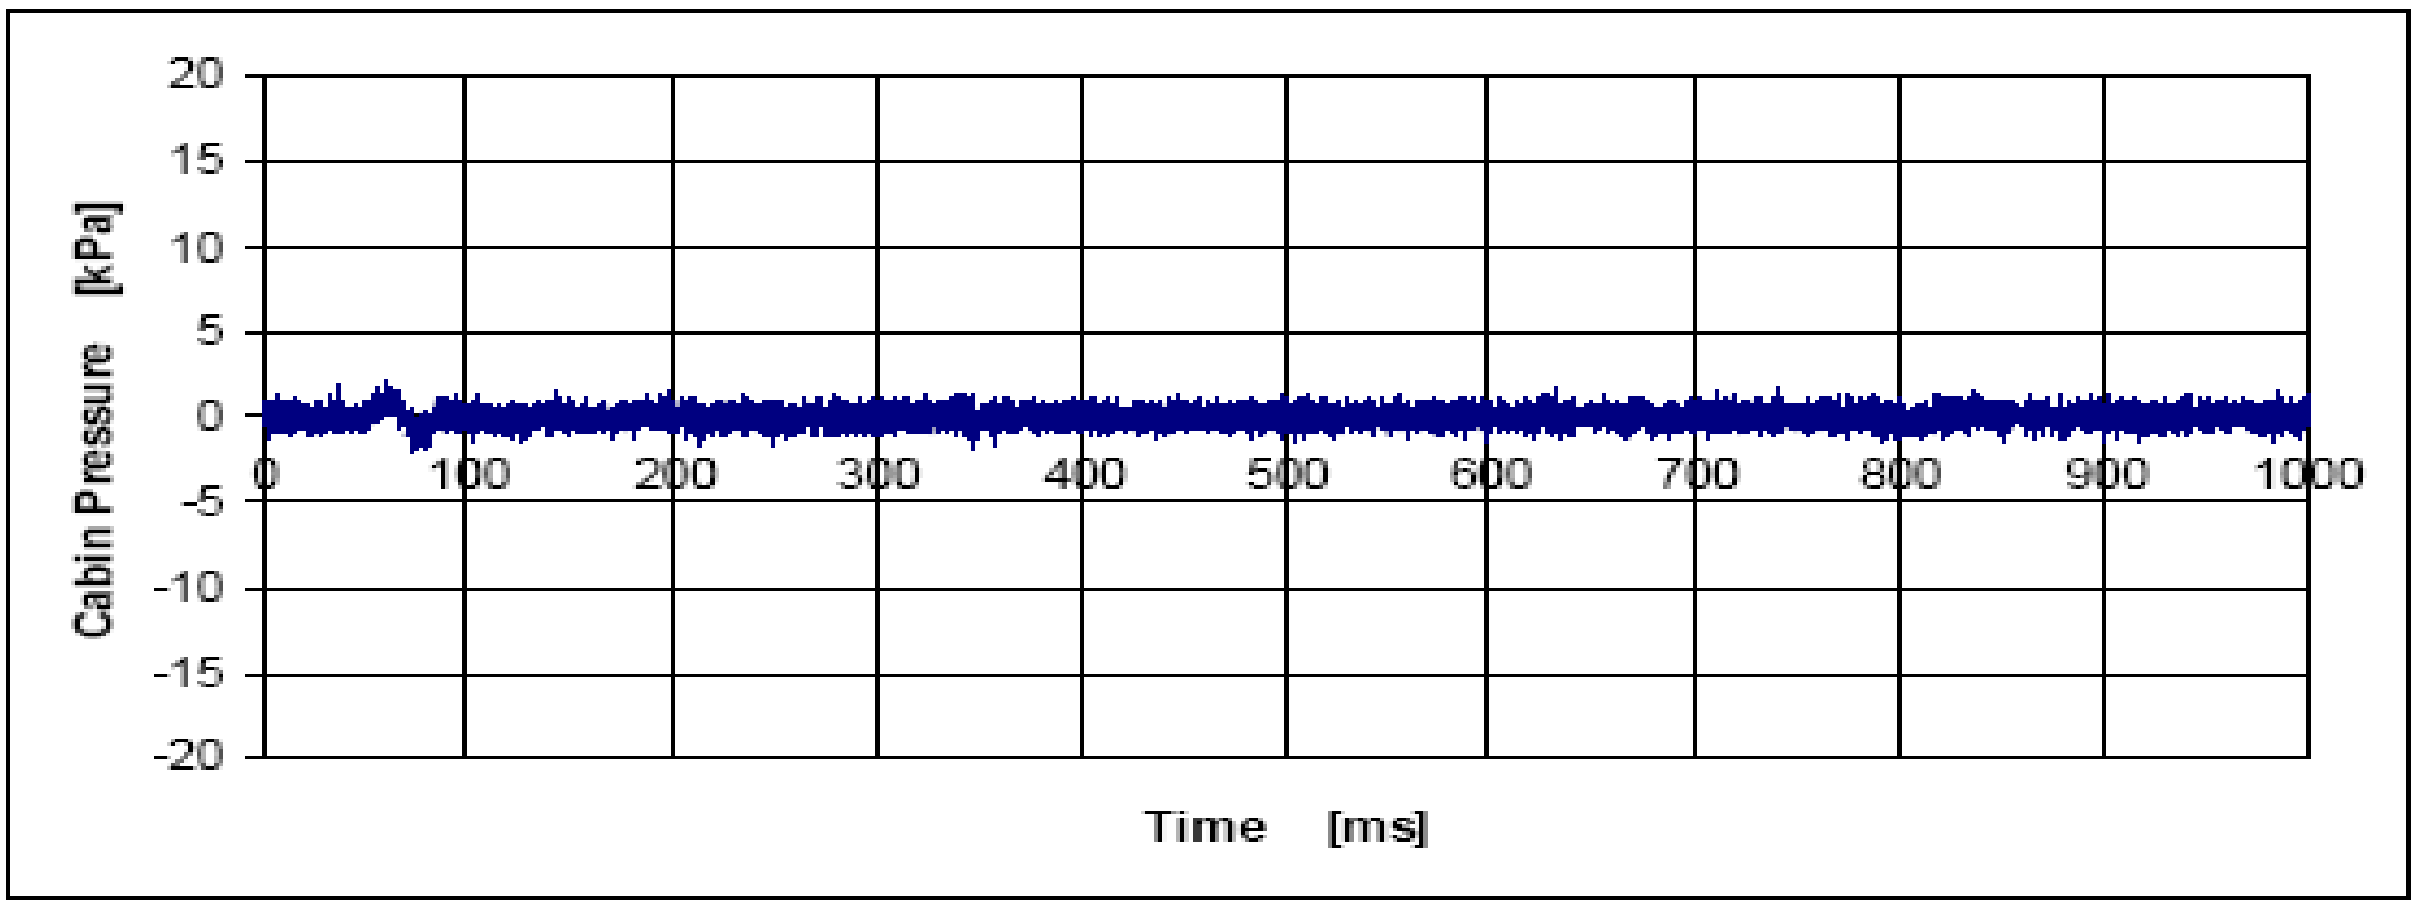
Figure 93: Cabin Pressure in Machine #2 (Yamanashi P) - Anti-personnel Mine

Figure 94: Cabin Pressure in Machine #2 (Yamanashi P) - Anti-tank Mine

In this measurement a pair of pressure sensors (with full-scale of 200 kPa) are used assuming poor noise shielding in machine cabins. The sensors measured very little deviation from a noise level in the cabin at each anti-personnel mine blast and the sensors detected some fluctuation in the cabin pressure at each anti-tank mine blast as shown in section 11.2.2. The pressure data was insignificant and no explosion yielded a pressure change that exceeded 2 kPa (= 160 dB). The cabin pressure change was found to be no more the 160 dB, and therefore, the measurement data with the sound-level meter will be used for the analysis in the following chapters.

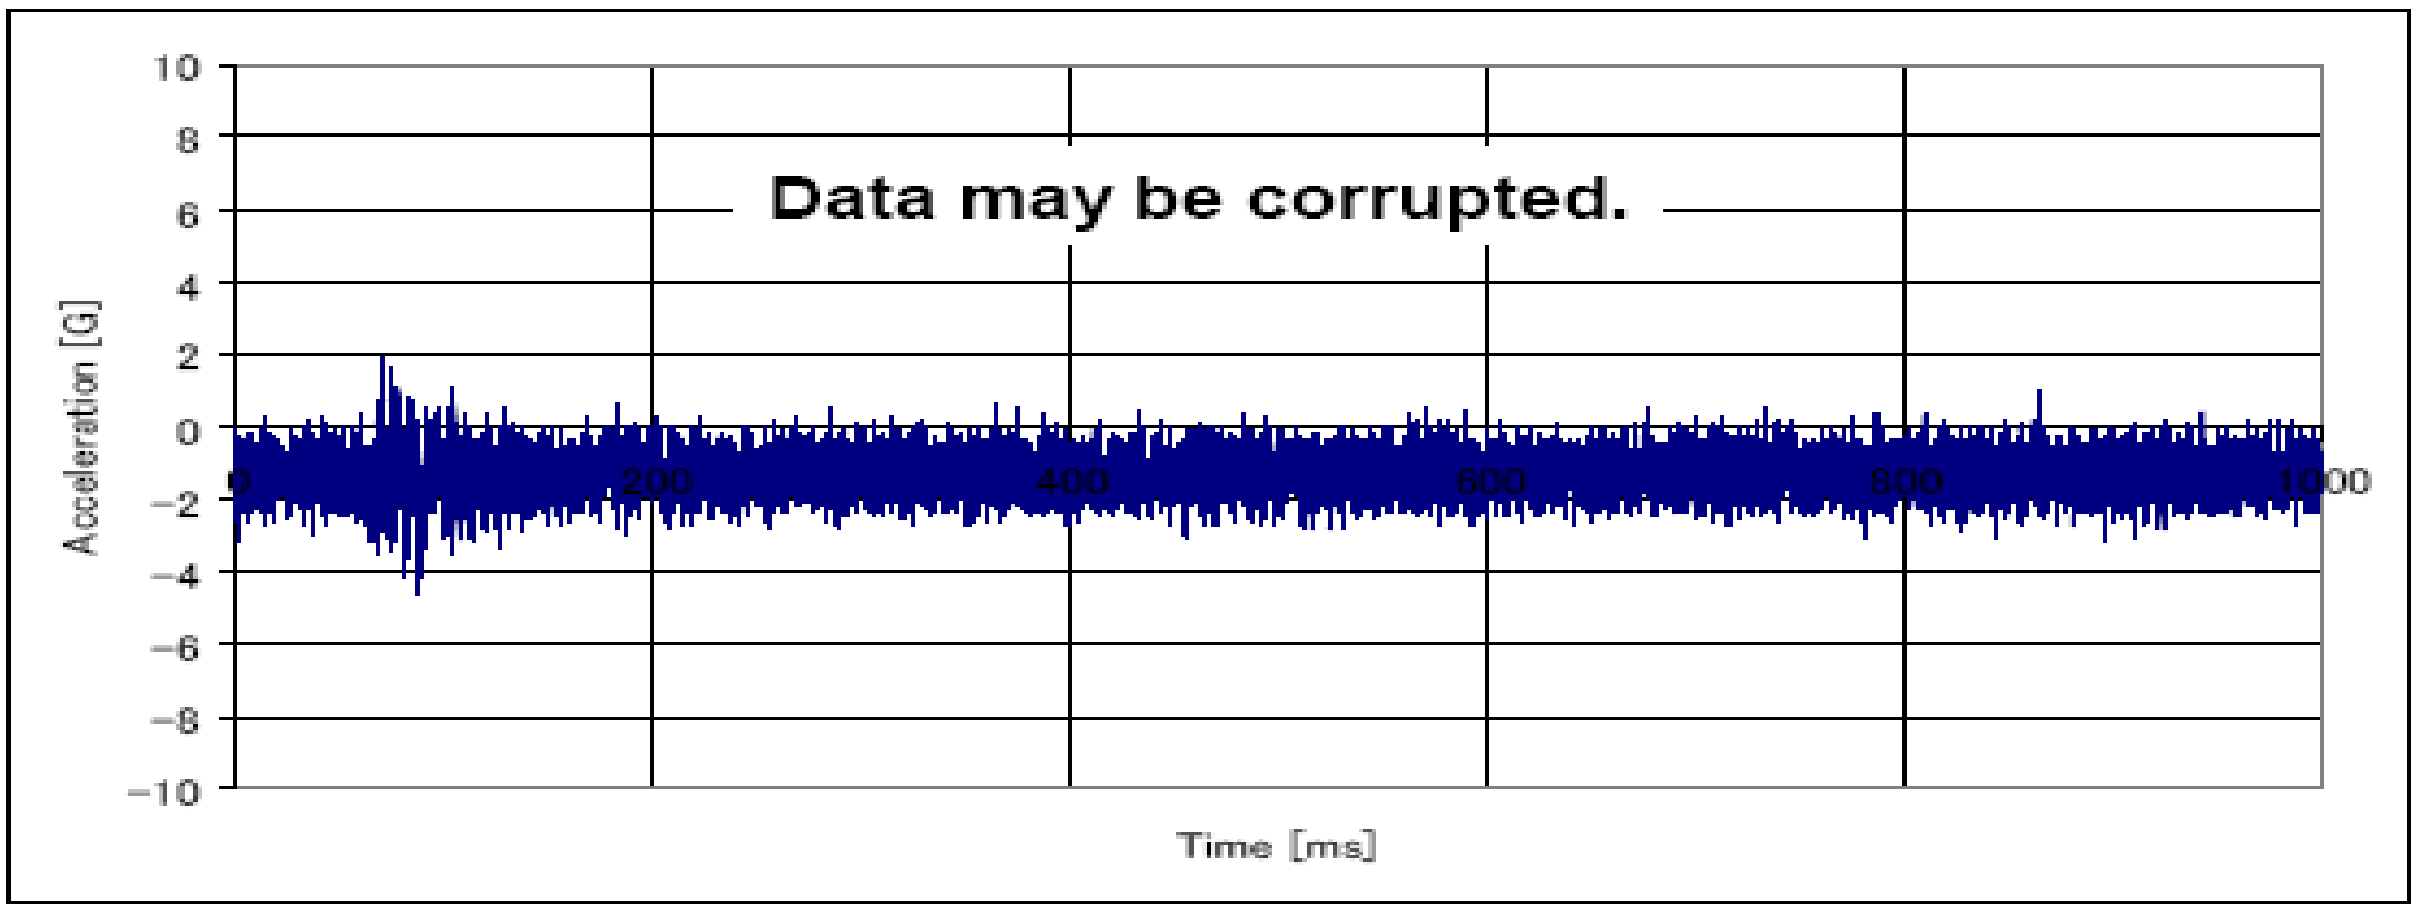
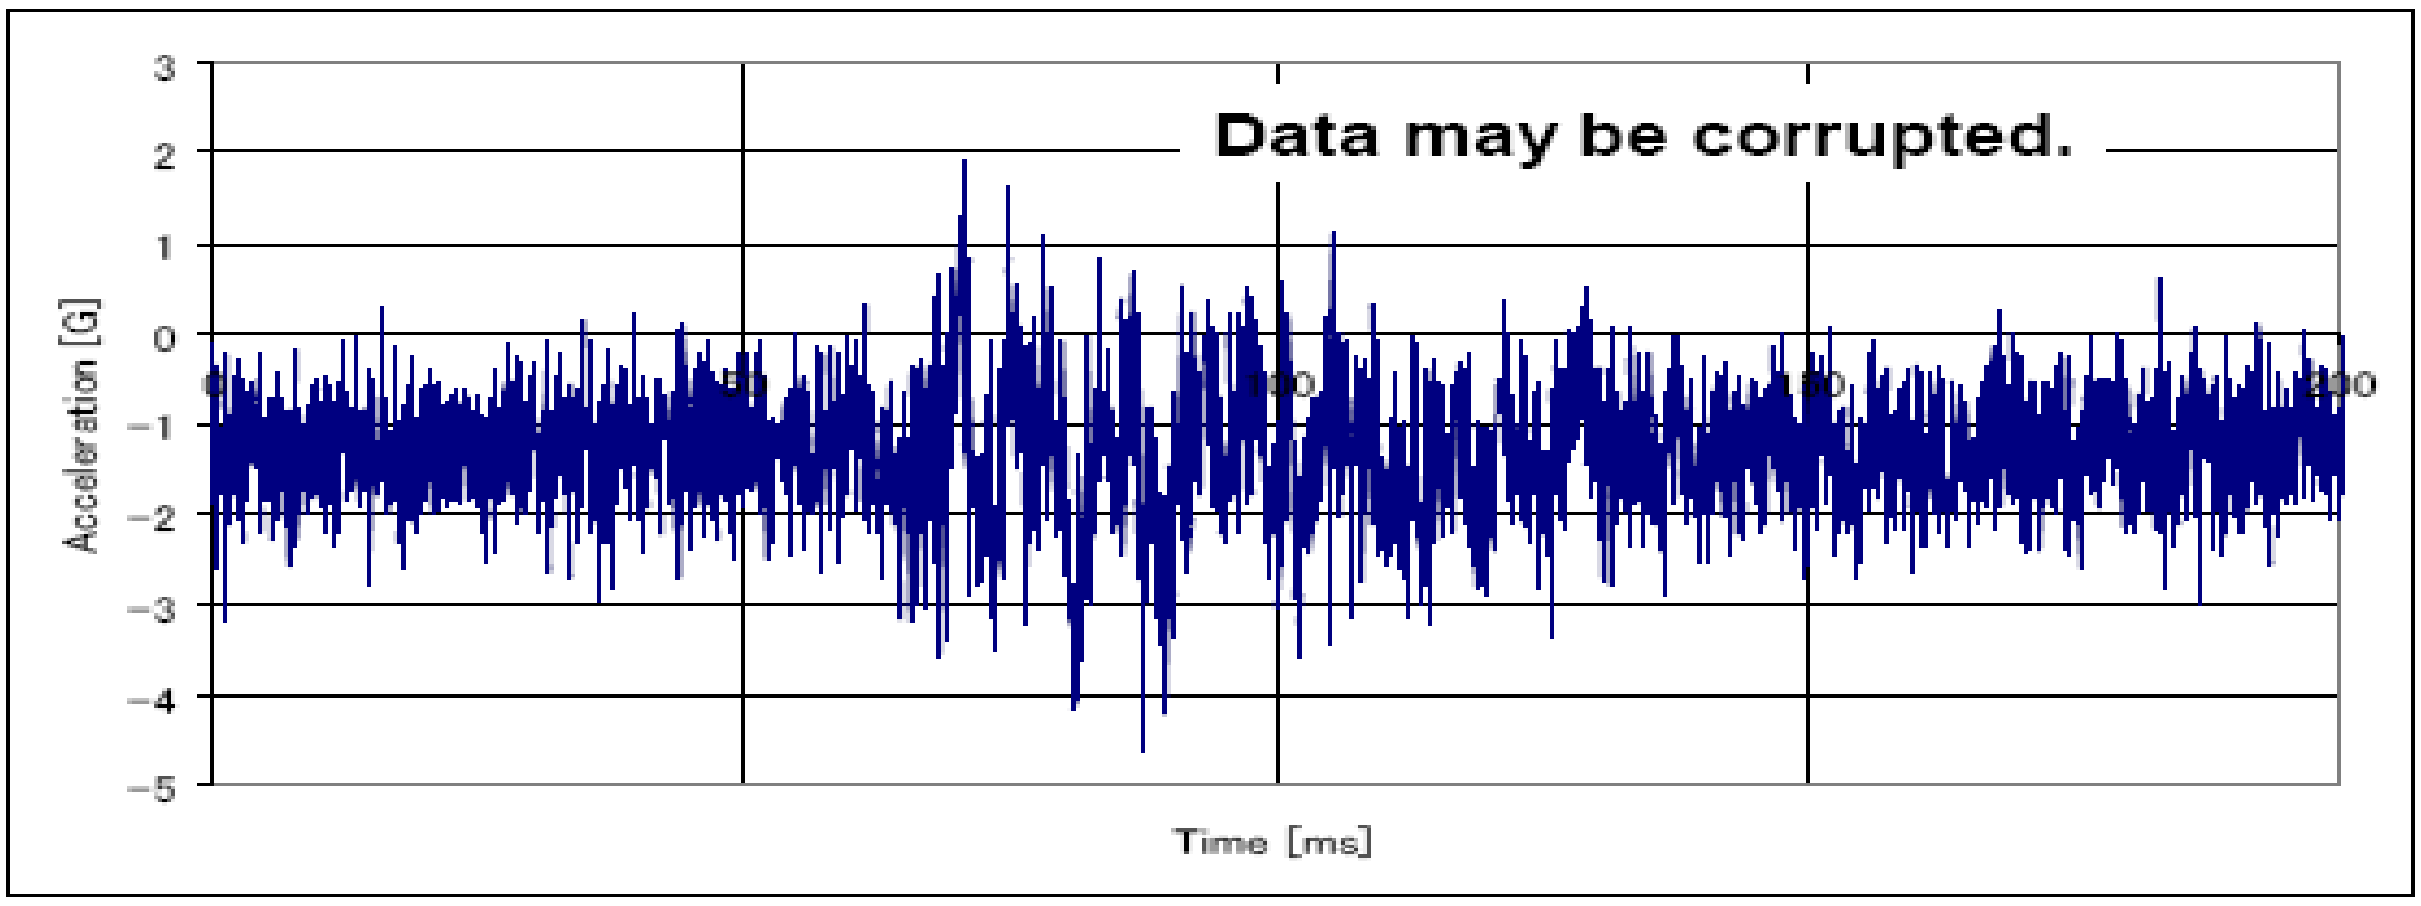
Figure 95: Floor Acceleration in Machine #2 (Yamanashi P) - Anti-personnel Mine [1/2]

Figure 96: Floor Acceleration in Machine #2 (Yamanashi P) - Anti-personnel Mine [2/2]

The measurement data in section 11.2.3 seem too small compared to other results of the same experiments on other two machines.

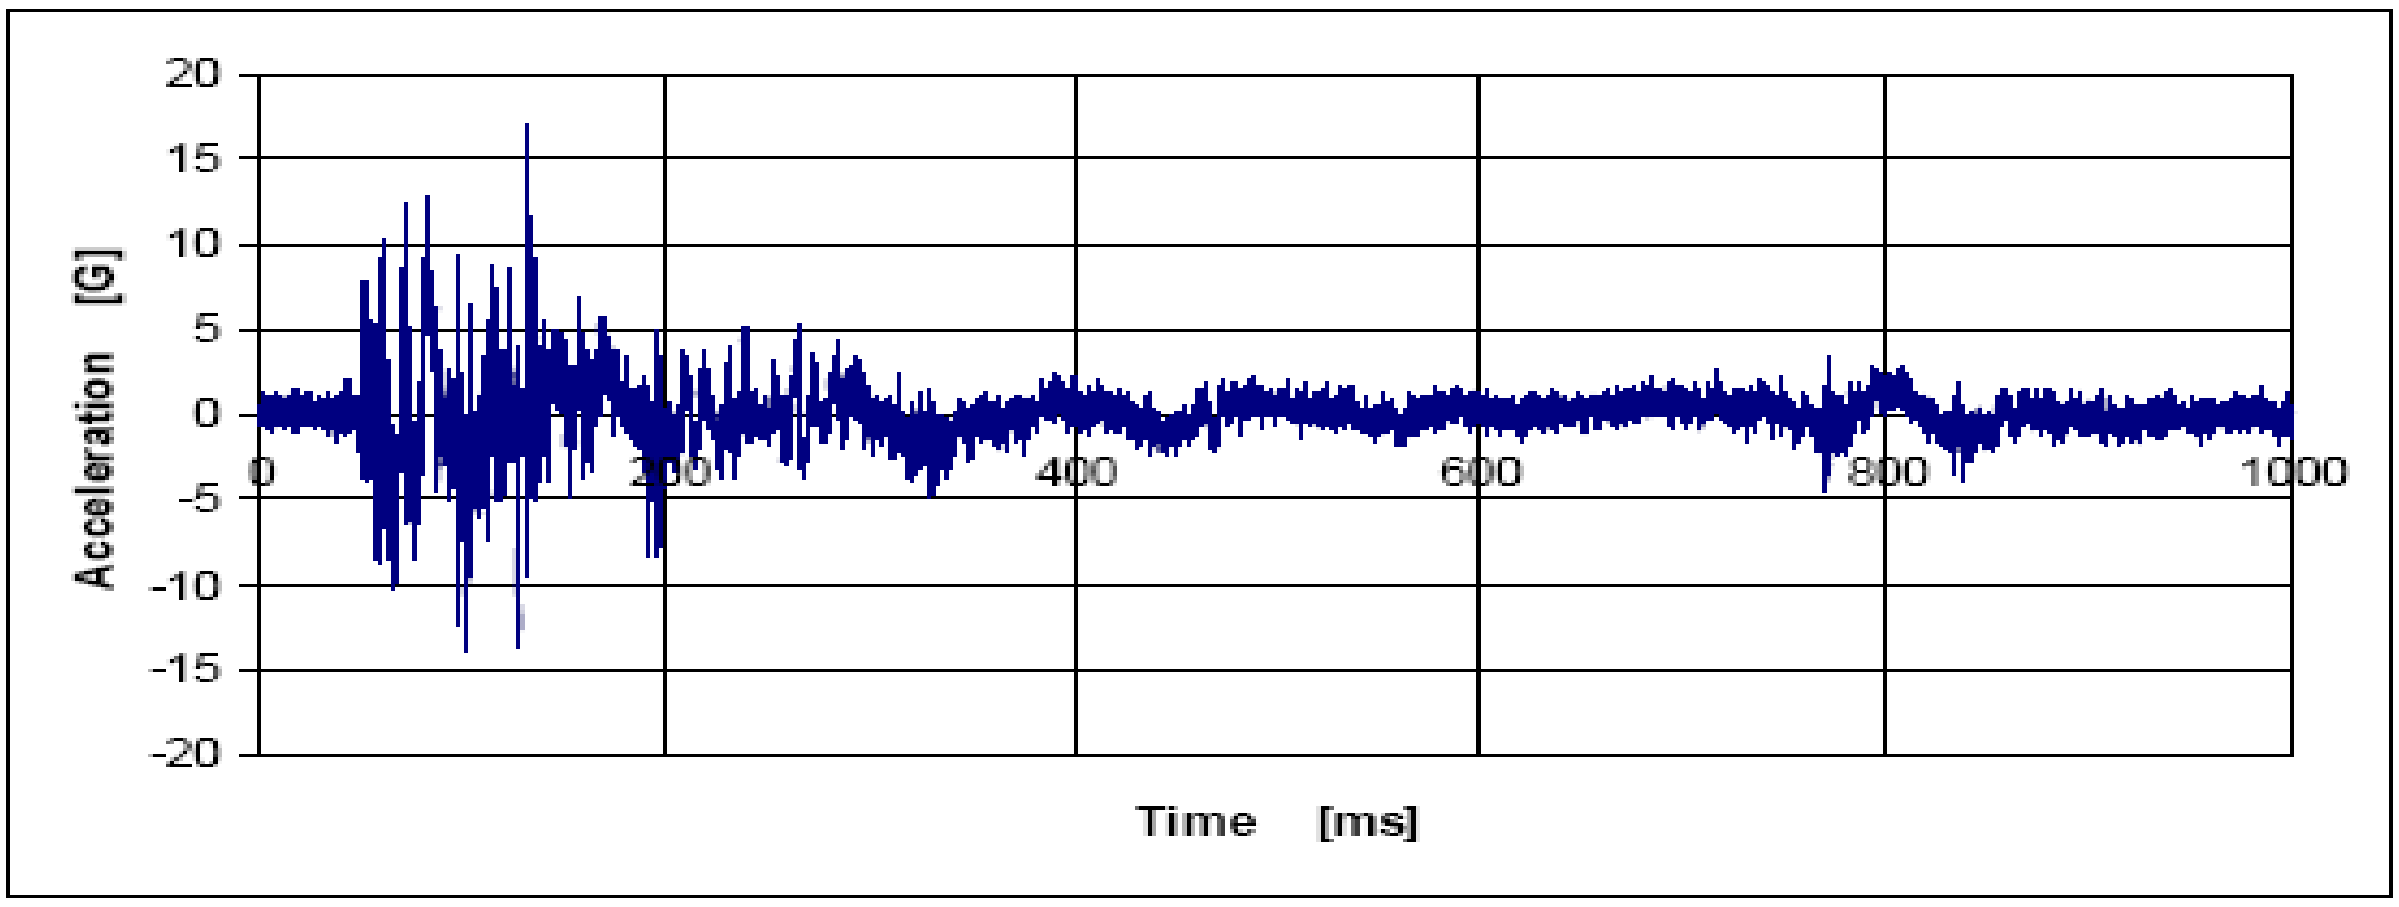
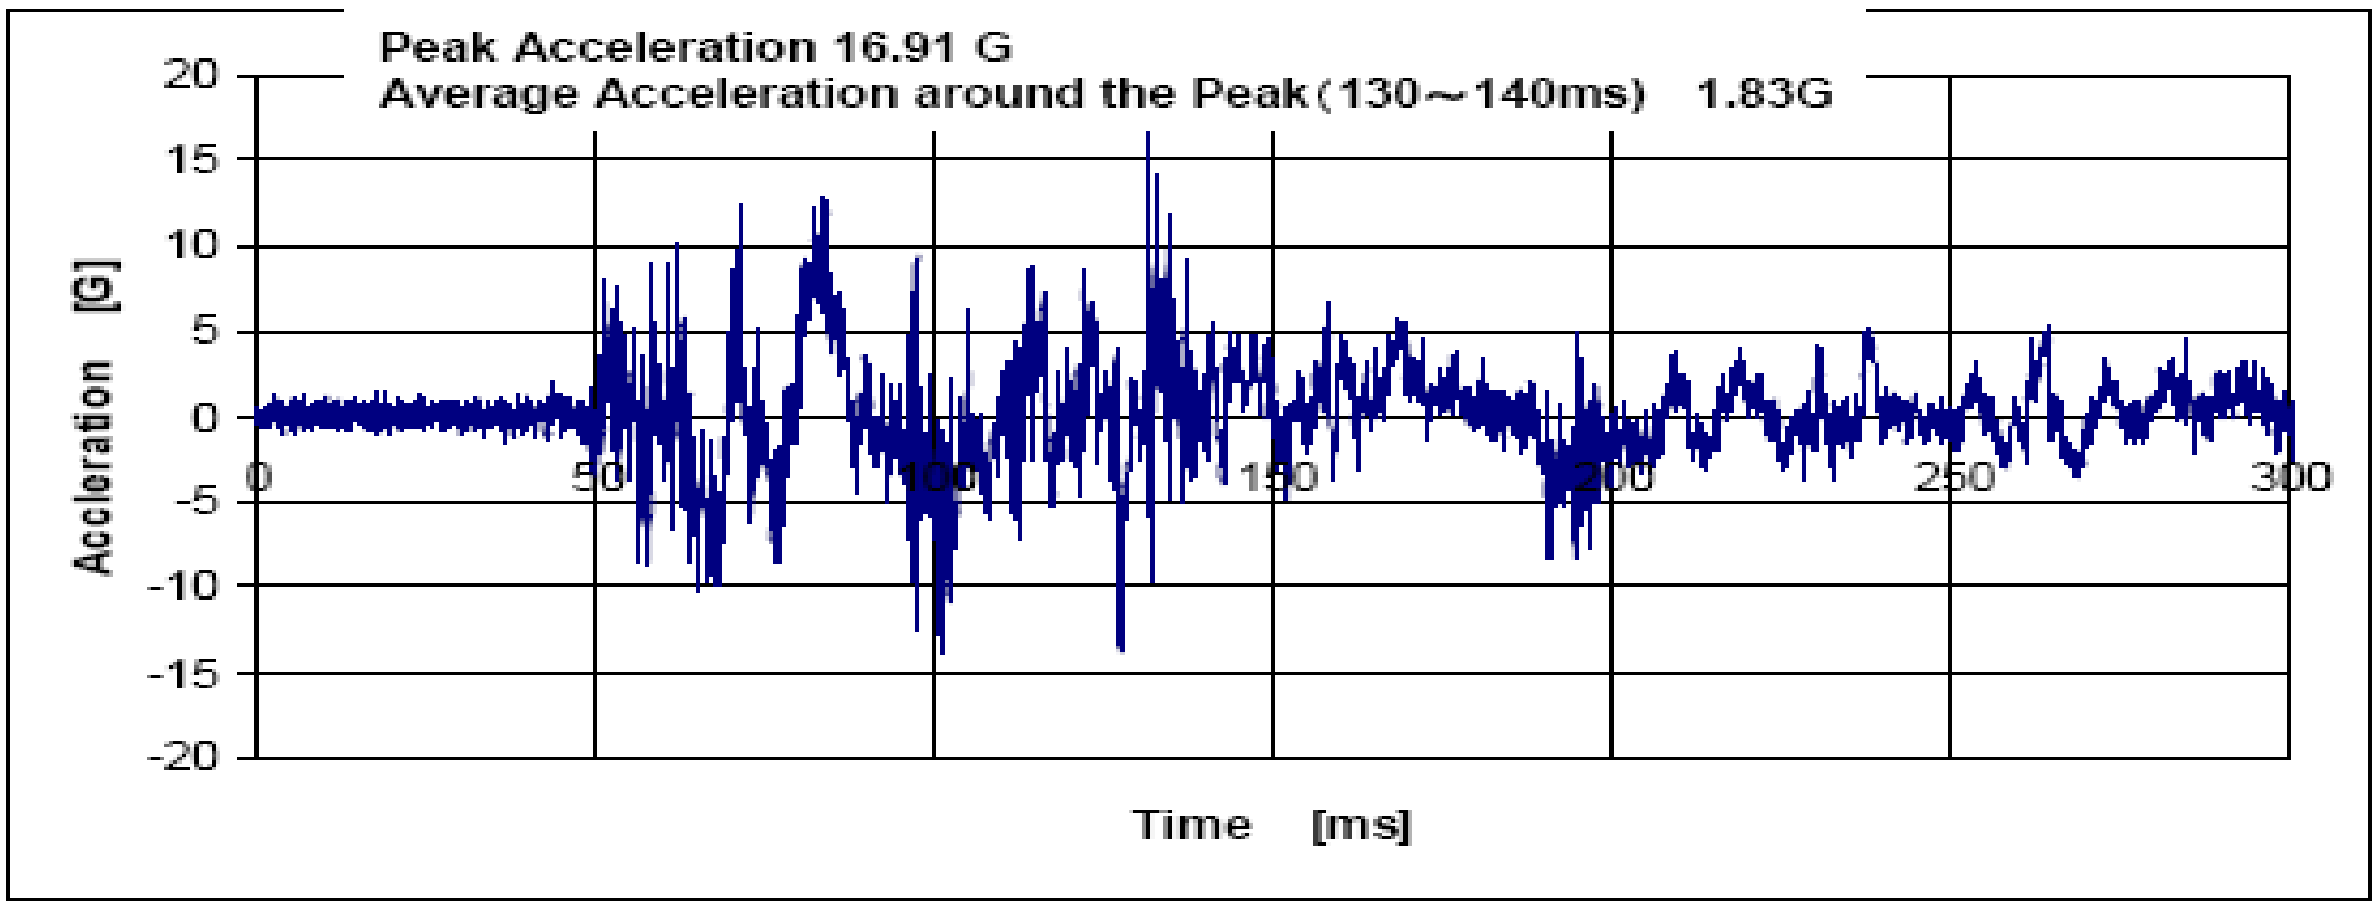
Figure 97: Floor Acceleration in Machine #2 (Yamanashi P) - Anti-tank Mine [1/2]

Figure 98: Floor Acceleration in Machine #2 (Yamanashi P) - Anti-tank Mine [2/2]
