PROJECT FOR RESEARCH AND DEVELOPMENT OF DEMINING RELATED EQUIPMENT IN CAMBODIA

No. 3

SURVIVABILITY TEST

PUSH TYPE MACHINE

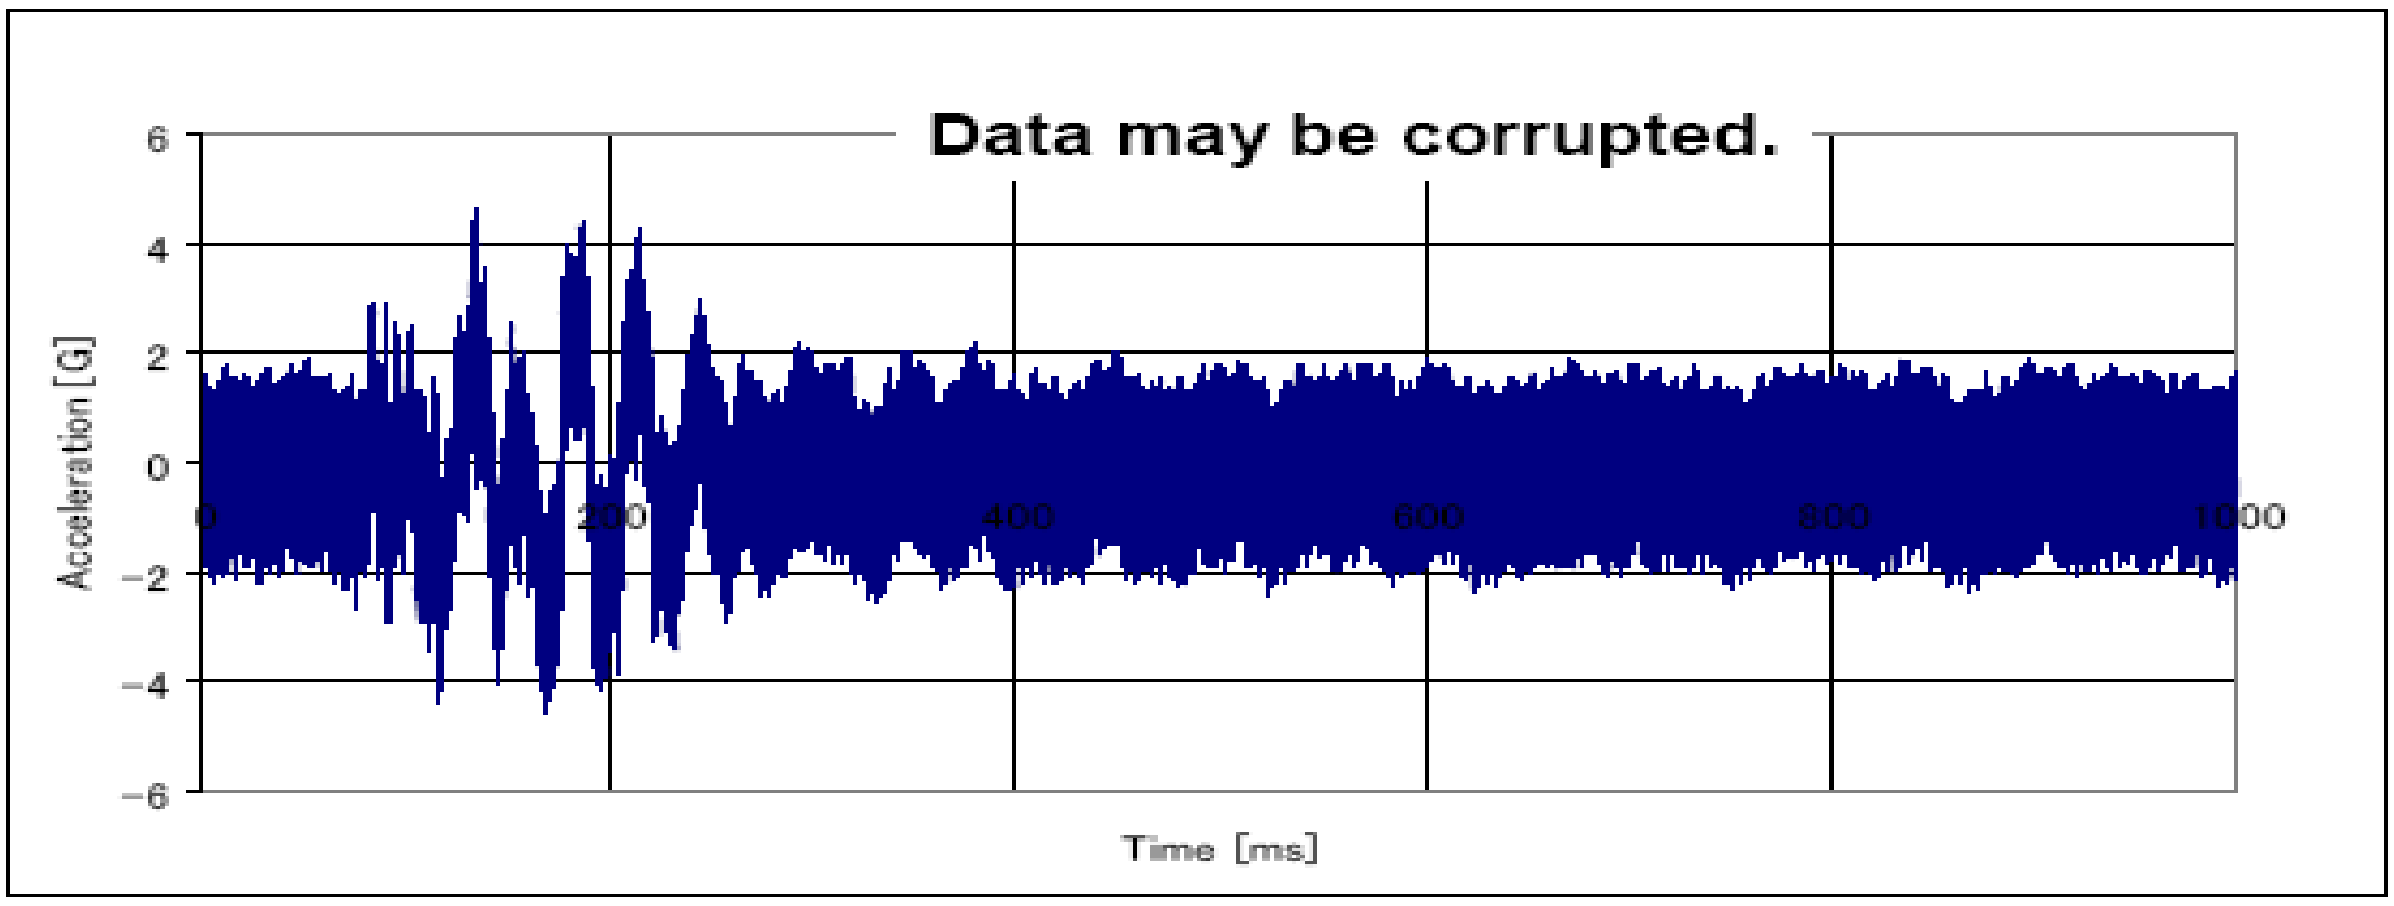
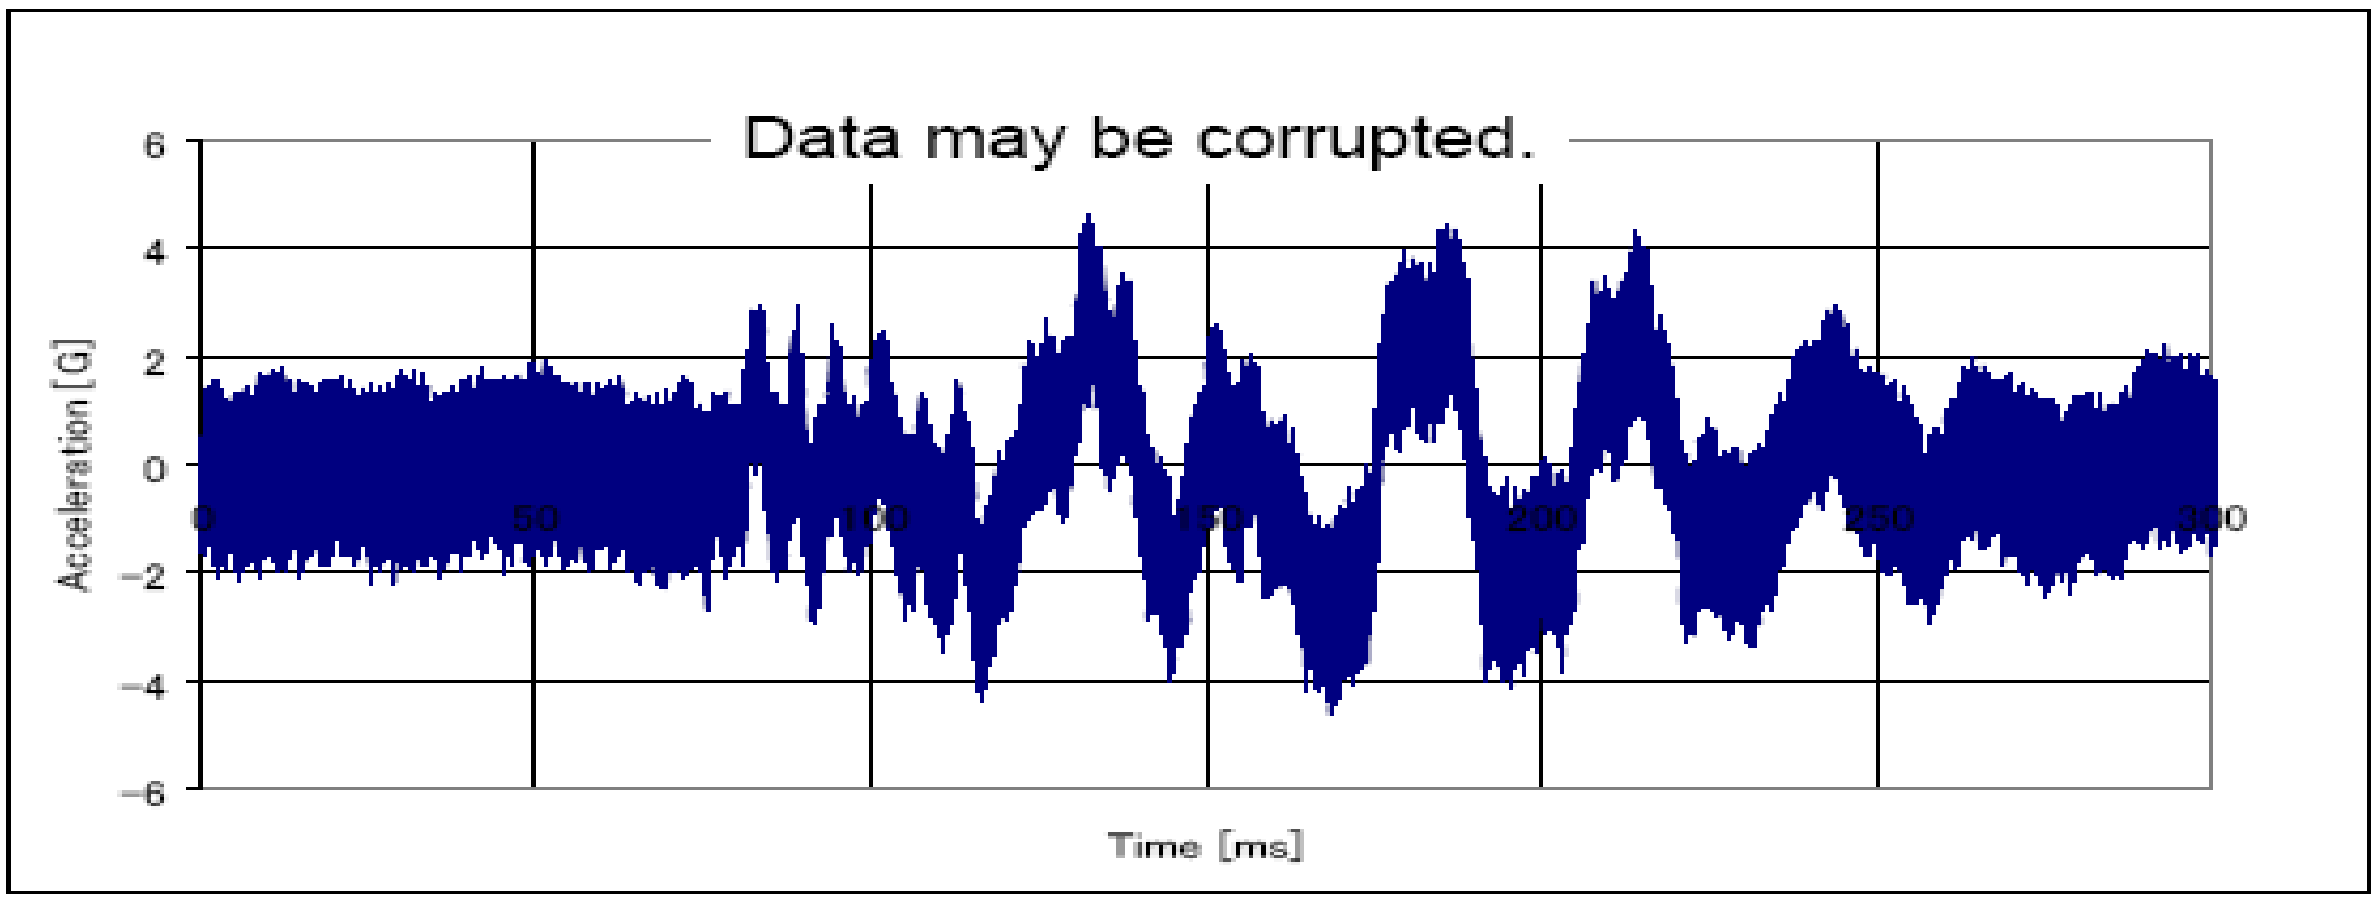
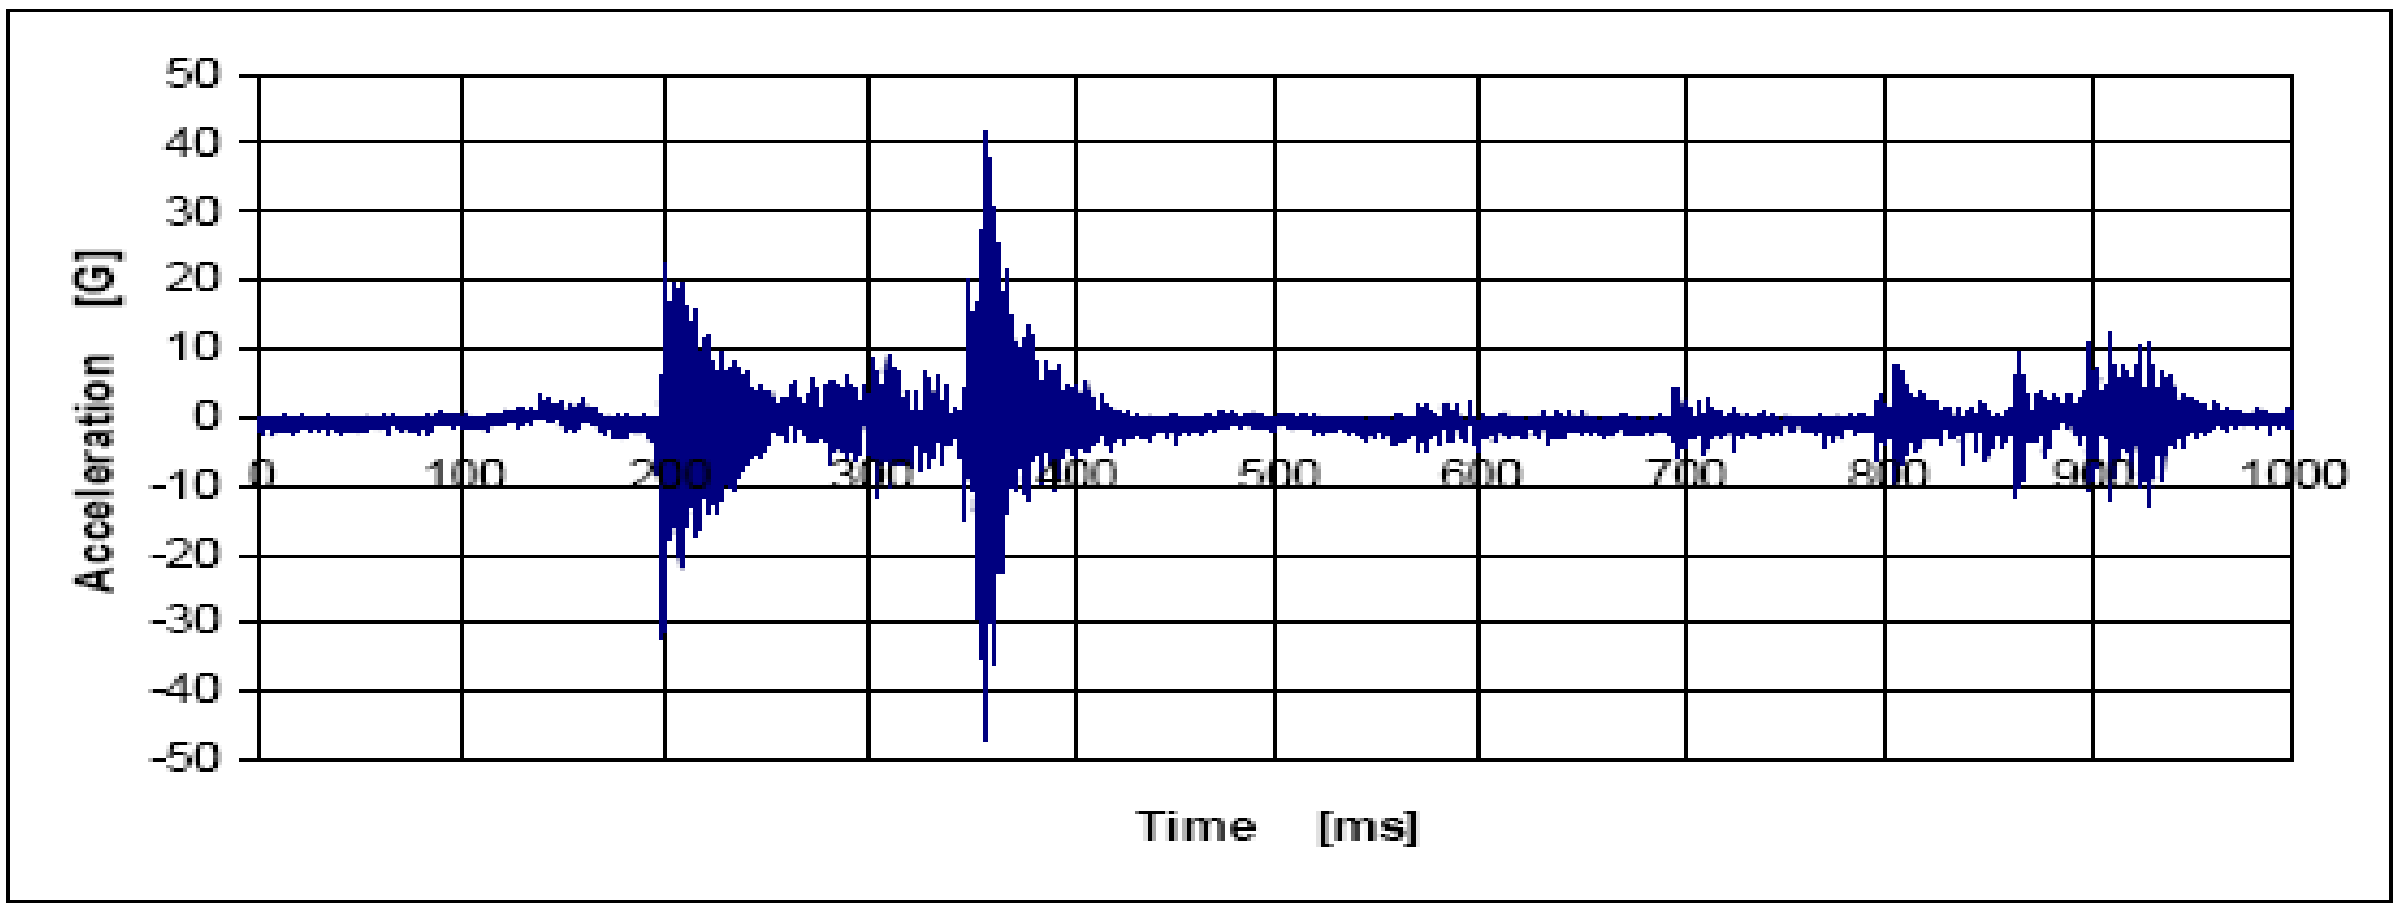
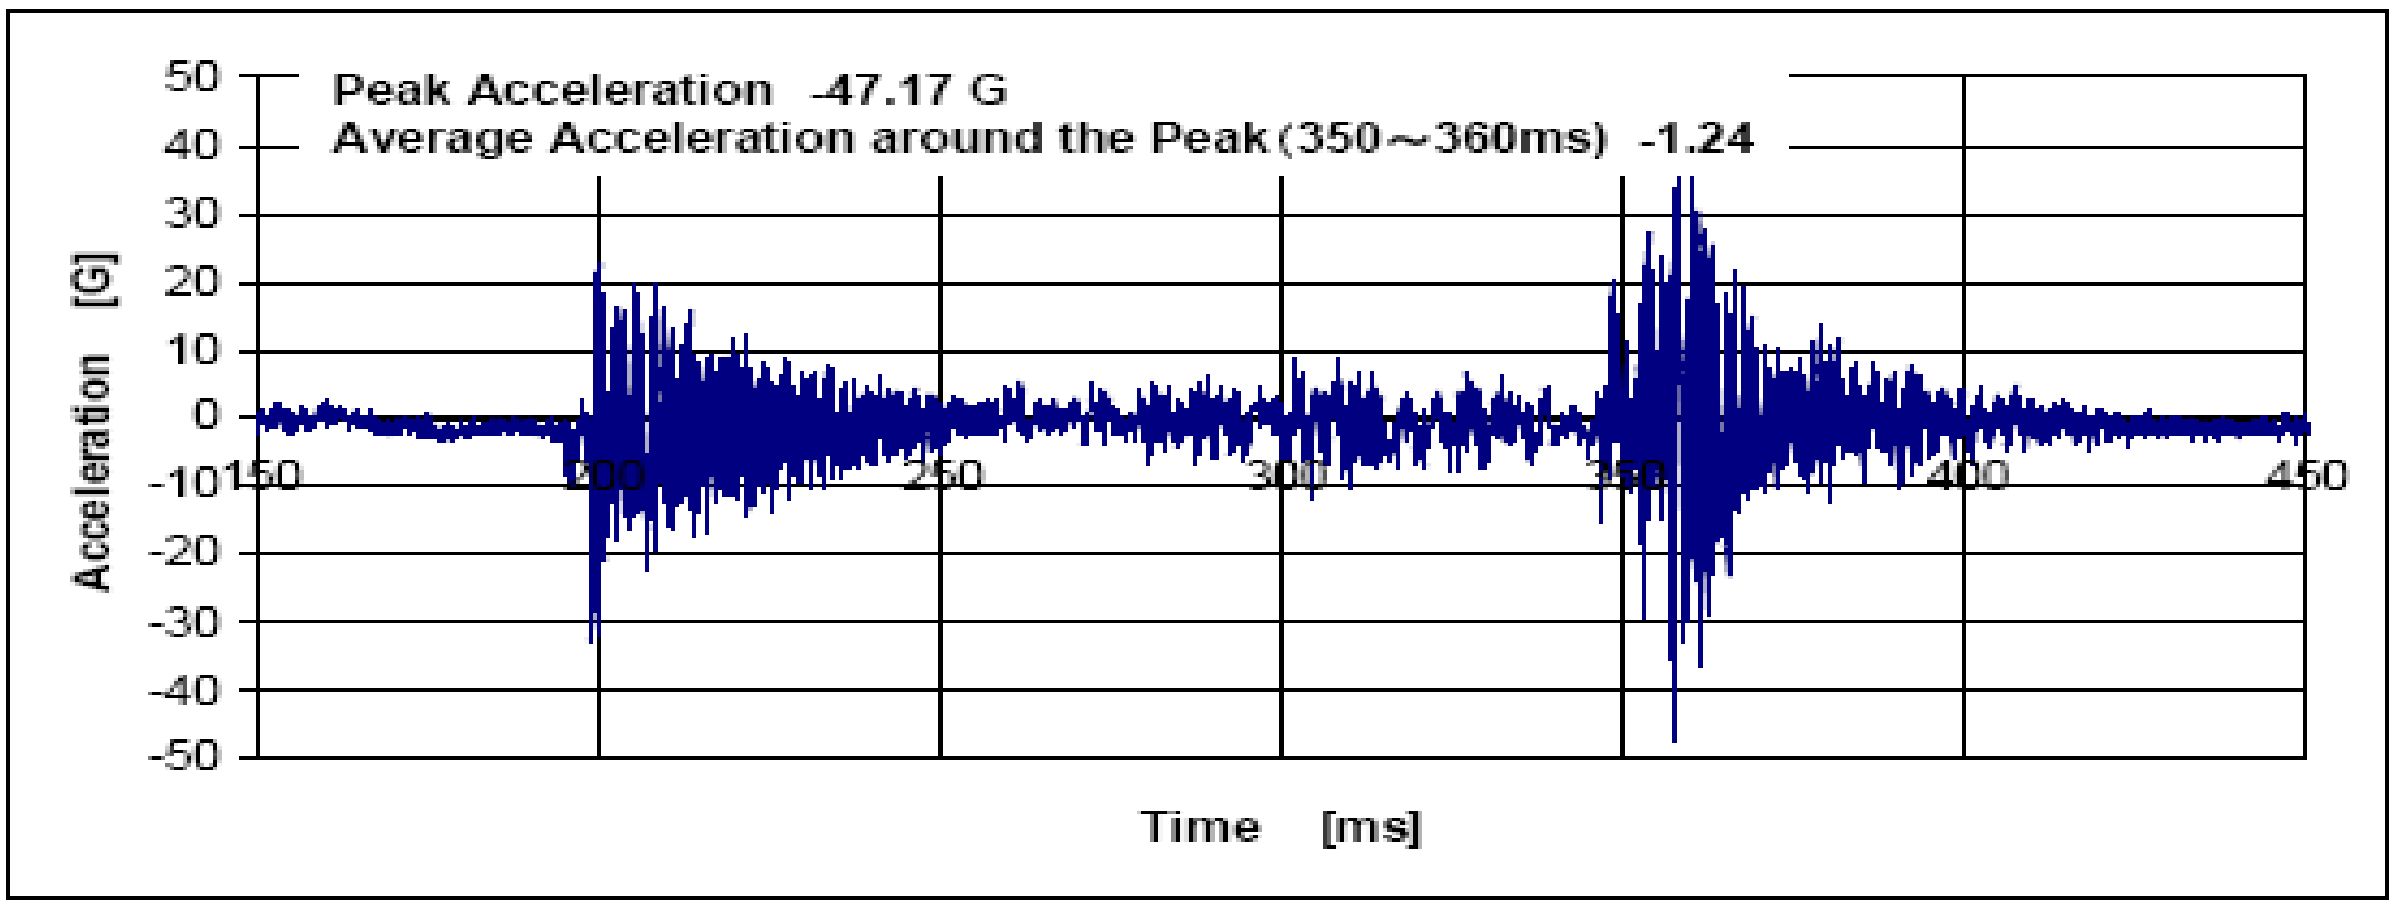
Figure 99: Seat Acceleration in Machine #2 (Yamanashi P) - Anti-personnel Mine [1/2]

Figure 100: Seat Acceleration in Machine #2 (Yamanashi P) - Anti-personnel Mine [2/2]

Figure 101: Seat Acceleration in Machine #2 (Yamanashi P) - Anti-tank Mine [1/2]

Figure 102: Seat Acceleration in Machine #2 (Yamanashi P) - Anti-tank Mine [2/2]

The acceleration data in section 11.2.4 show some response to mine blasts, but the noise level of this measurement was as high as +/- 2 G, far exceeding the noises in other experiments.

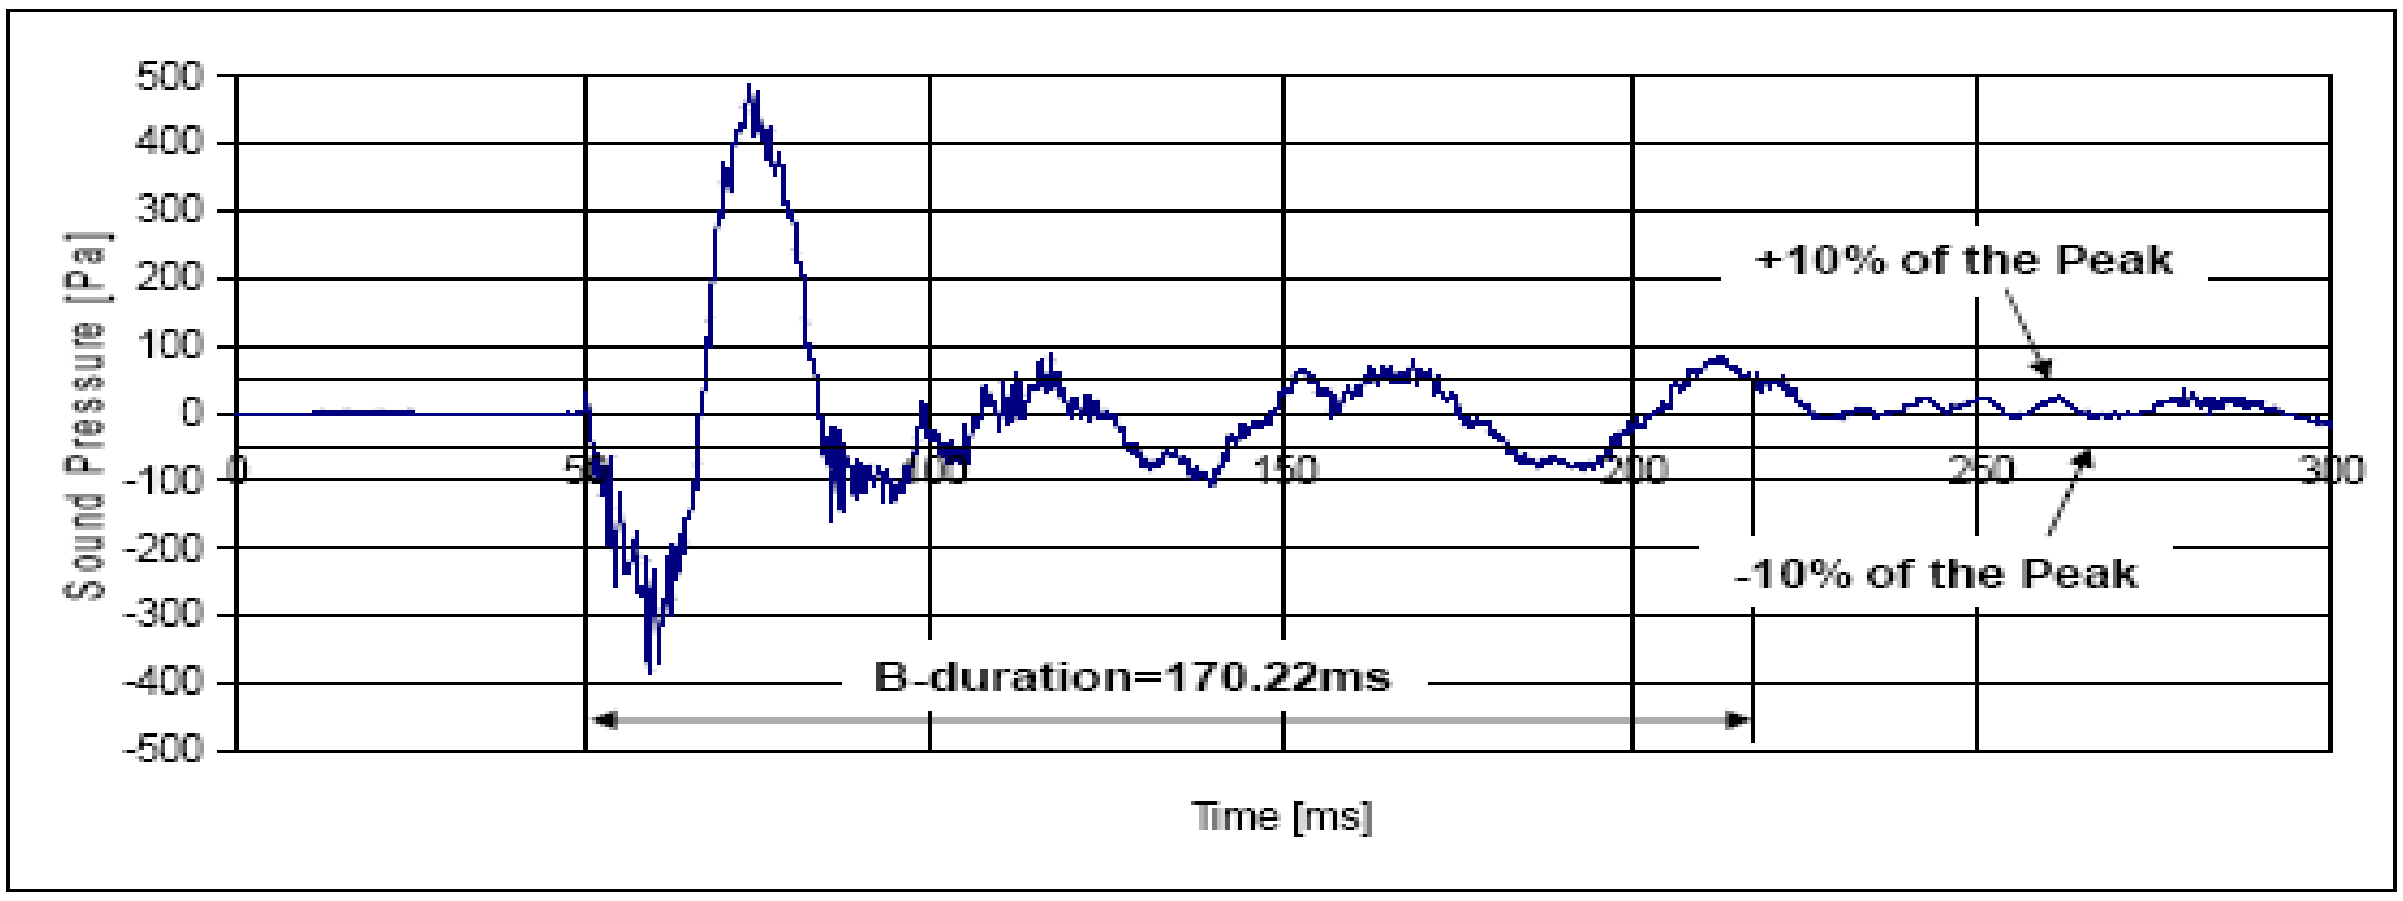
The peak sound pressure for Anti in section 11.2.1 exceeded 200 Pa. The B-duration of this pressure-time history is shown below:

Figure 103: B-duration of Sound Pressure in Machine #2 (YAMANASHI P) - Anti-tank Mine

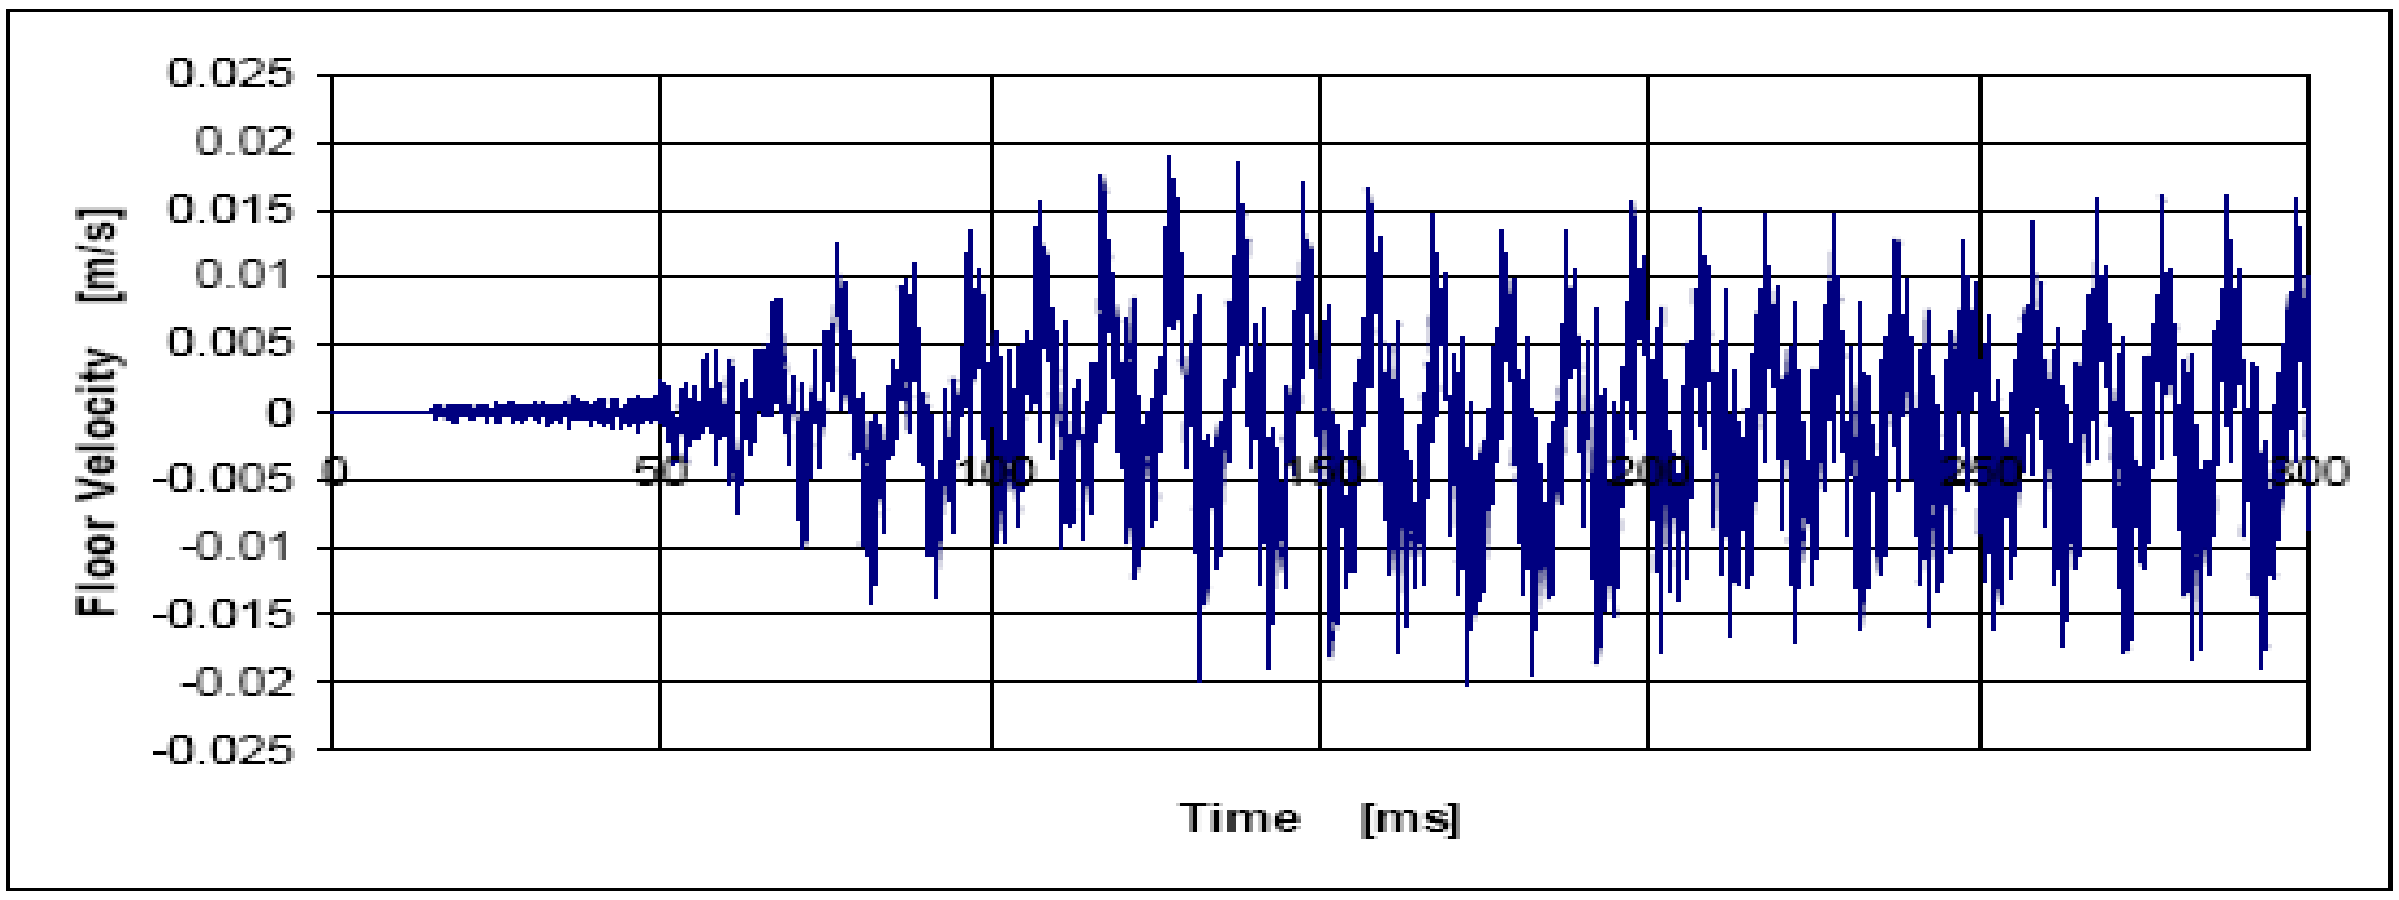
Figure 104: Floor Velocity-Time Chart for Machine #2 (YAMANASHI P) - Anti-tank Mine

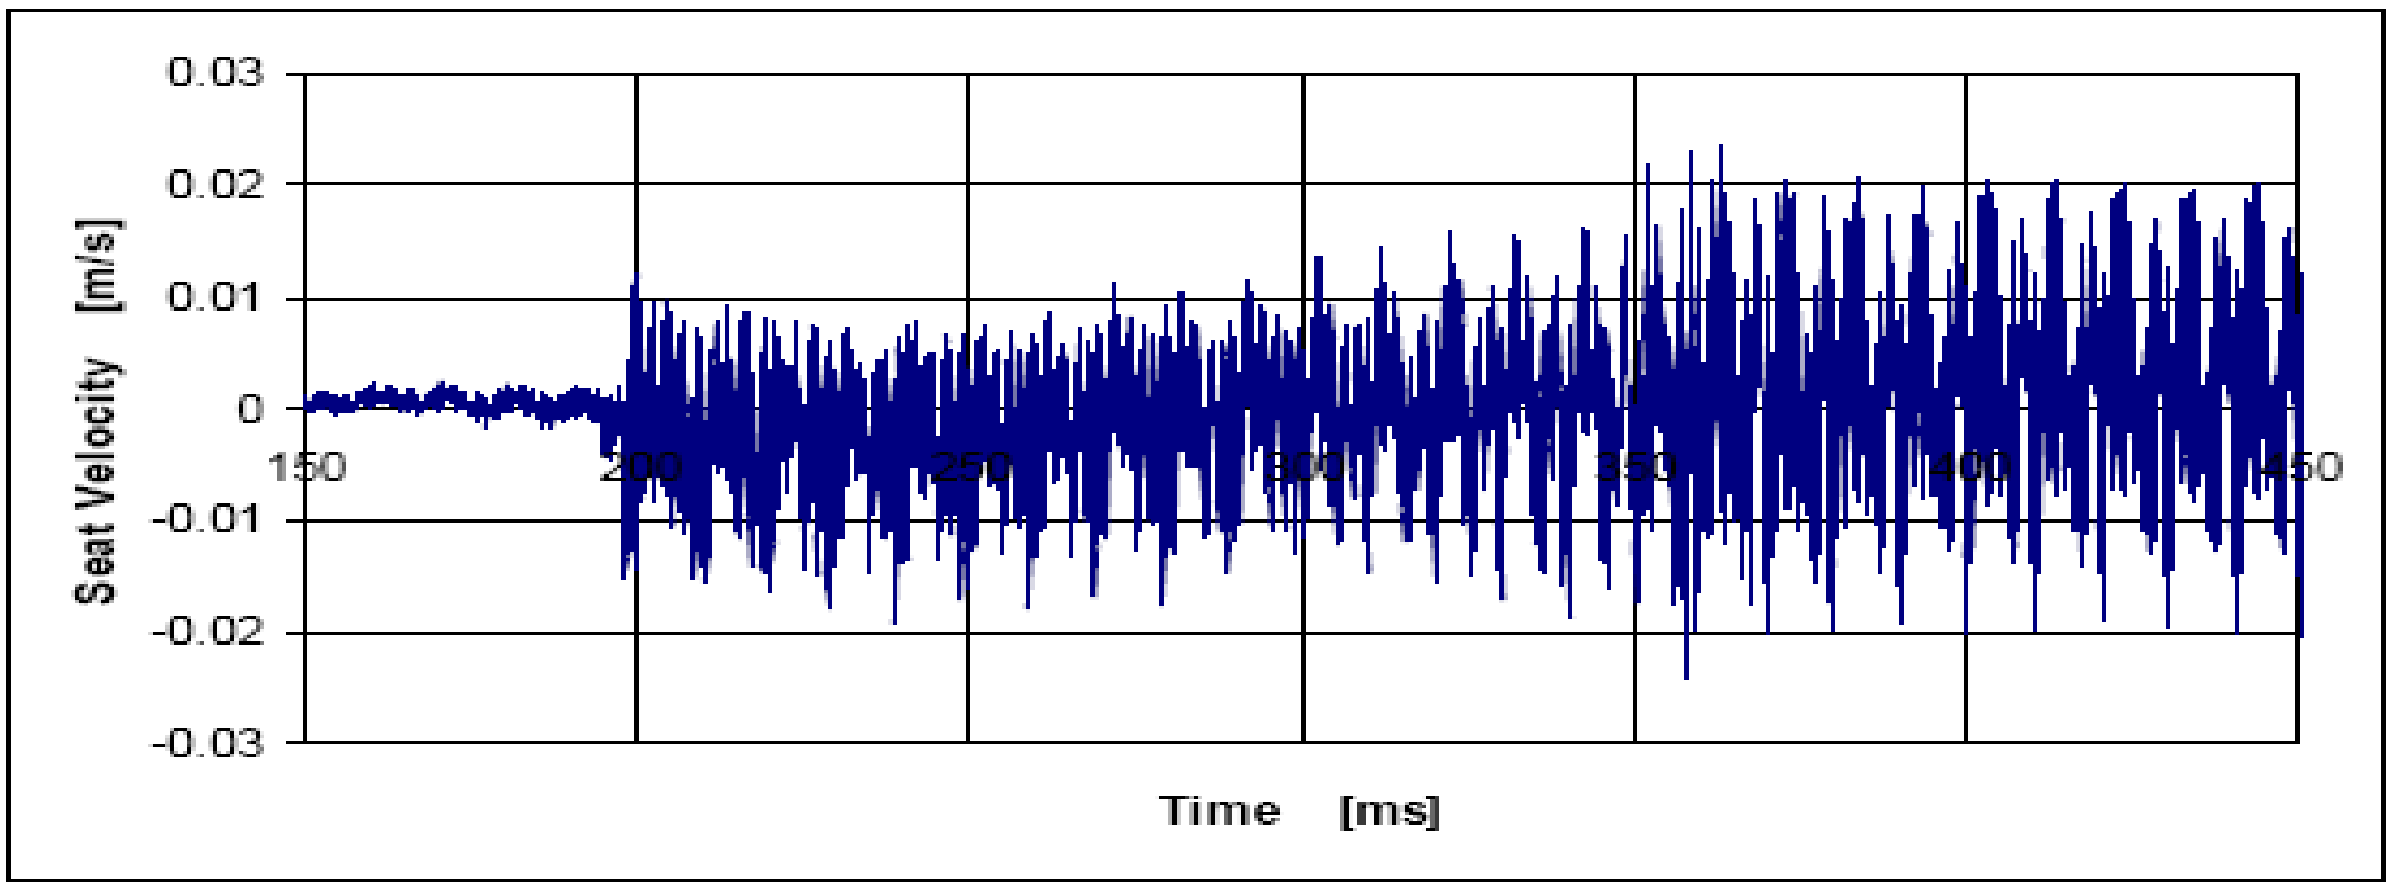
Figure 105: Seat Velocity-Time Chart for Machine #2 (YAMANASHI P) - Anti-tank Mine

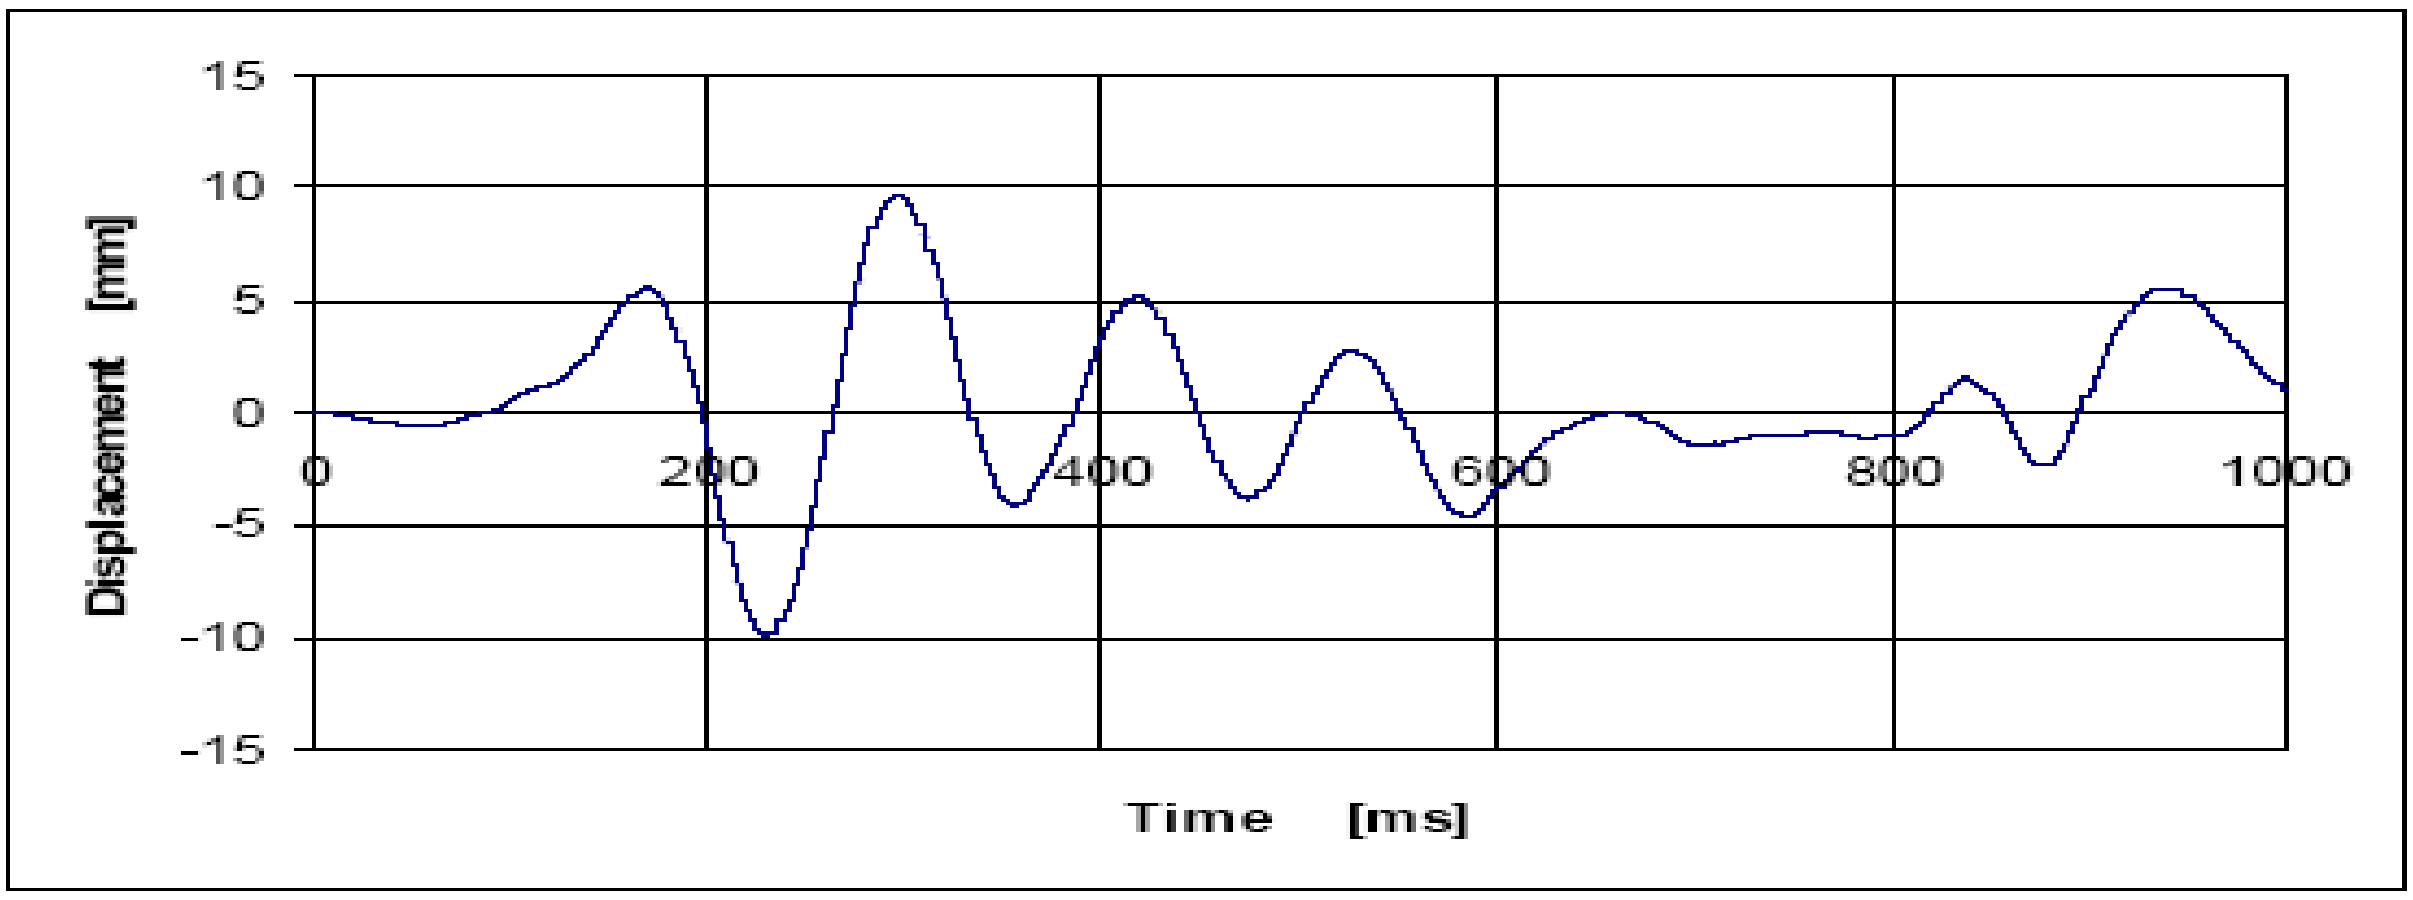
Thus, we found the maximum value of the acceptable displacement on the operator seat is 56mm.

Figure 106: Simulated Human Body Displacement in Machine #2 (YAMANASHI P) - Anti-tank Mine
