**PROJECT FOR RESEARCH AND DEVELOPMENT OF DEMINING
RELATED EQUIPMENT IN CAMBODIA**

**REPAIR &
MAINTENANCE**

SWING TYPE MACHINE

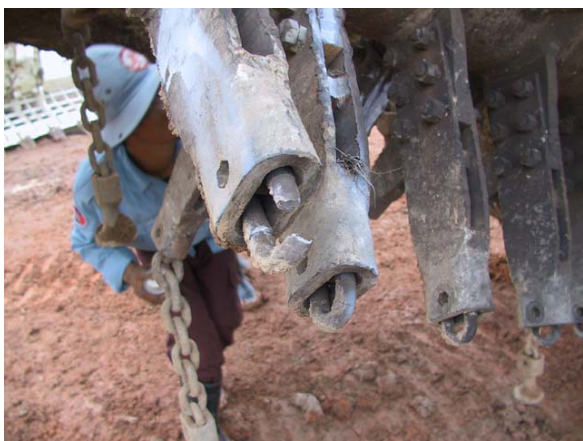
Figure 114: Chains are broken from Anti-tank blast

a) Chain / Replacement	Time/1pc	Quantity	Total Time	Labor
b) Holder / Repair	2minutes	11		
c) Rubber Plate	15minutes	6	22minutes	1
d) Steel bar for rubber plate	10minutes	7	1h 30m	2
	*	-	1h 10m	2

Description	Equipment
a) Chain / Replacement	Hexagon wrench
b) Holder / Repair	Steel cable, Lever chain block, Burner
c) Rubber Plate	Spanners

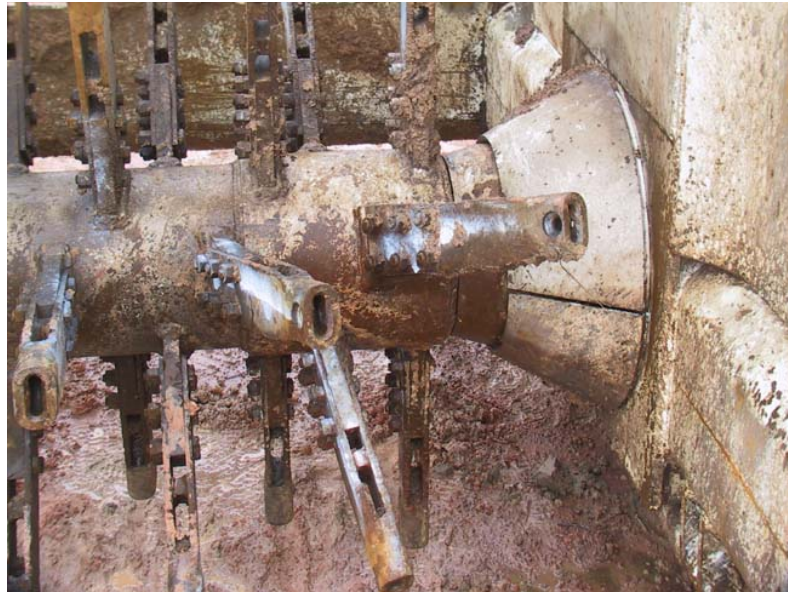
b) Holder

Figure 115: Holders are bending from Anti-tank blast

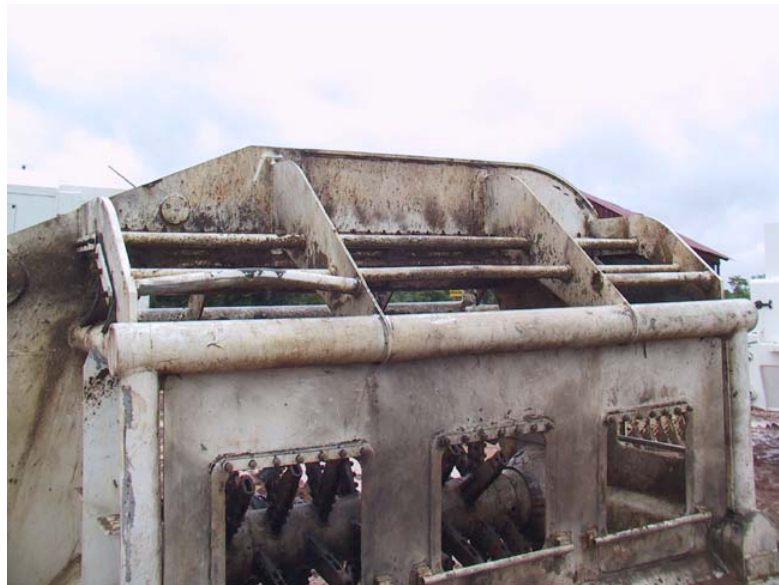
c) Rubber Plate

Figure 116: Rubber plate to protect dust are blown away by Anti-tank blast
