**PROJECT FOR RESEARCH AND DEVELOPMENT OF DEMINING  
RELATED EQUIPMENT IN CAMBODIA**

**REPAIR &  
MAINTENANCE**

**SWING TYPE MACHINE**

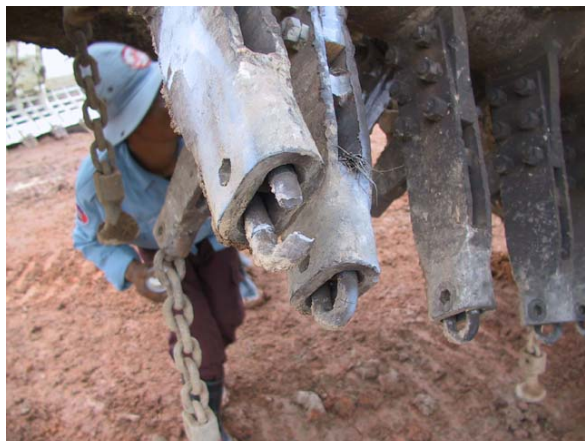
Figure 114: Chains are broken from Anti-tank blast

a) Chain / Replacement	Time/1pc	Quantity	Total Time	Labor
b) Holder / Repair	2minutes	11		
c) Rubber Plate	15minutes	6	22minutes	1
d) Steel bar for rubber plate	10minutes	7	1h 30m	2
	*	-	1h 10m	2

Description	Equipment
a) Chain / Replacement	Hexagon wrench
b) Holder / Repair	Steel cable, Lever chain block, Burner
c) Rubber Plate	Spanners

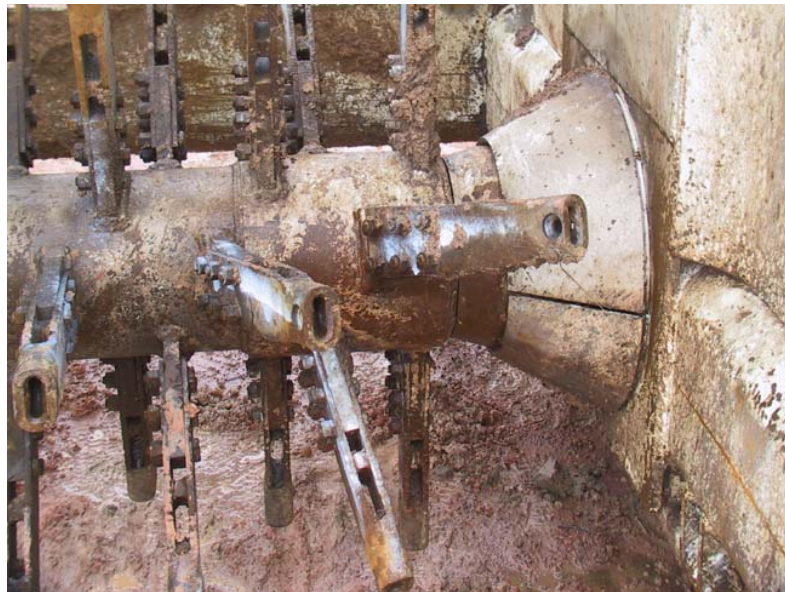
b) Holder

Figure 115: Holders are bending from Anti-tank blast

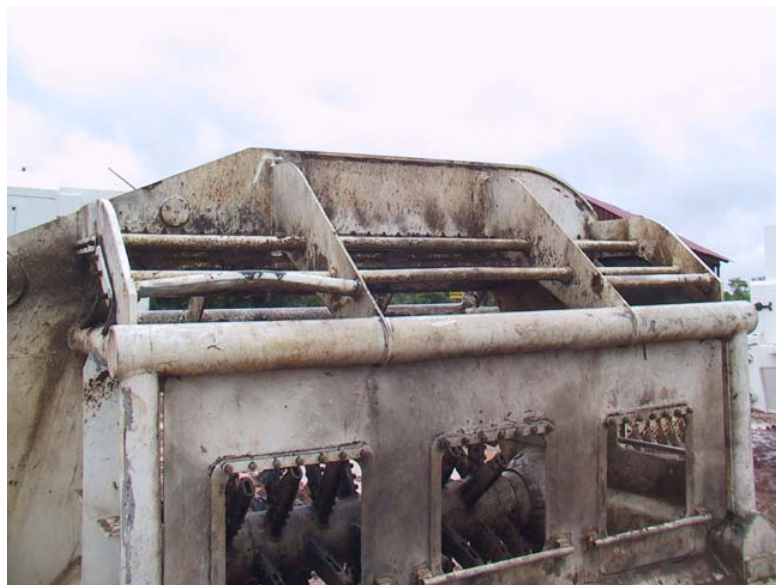
c) Rubber Plate

Figure 116: Rubber plate to protect dust are blown away by Anti-tank blast
